RC Certified Inspections

Comprehensive Structural & Mechanical Property Inspections

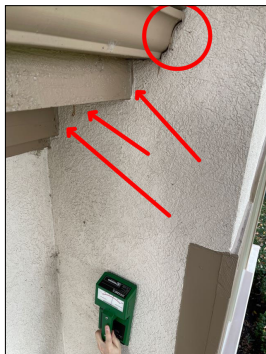
Always maintain sealant around the wood surfaces of the soffits and fascia boards where they actually protrude into the EIFS surfaces. The circle in the picture is that it appears that the basecoat mesh of the EIFS is visible. Requiring the gutter to be removed to seal it up.

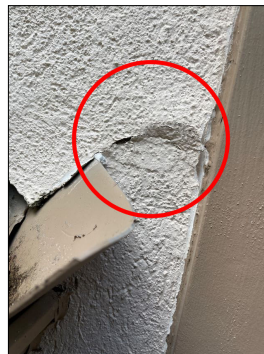
The EIFS surface is cracked at the kick out flashing on the garage north side next to the dining room window.

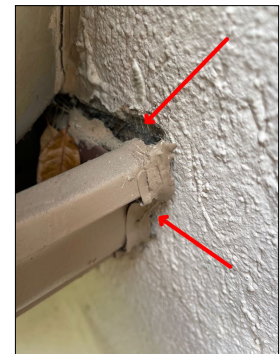
On the garage north side where the gutter meets the EIFS surface, the exterior surface is missing leaving the Base Coat MESH is visible.

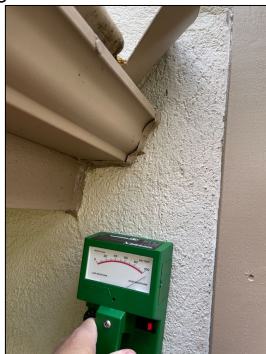
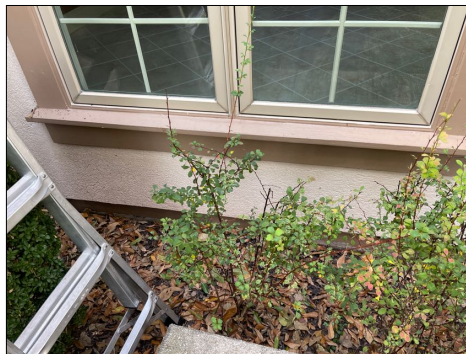
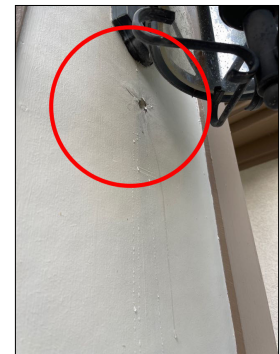
The siding has water damage and needs to be replaced were the front porch light fixtures are attached.

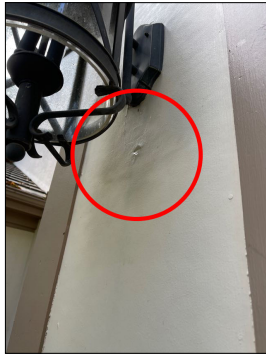
The siding has water damage and needs to be replaced were the front porch light fixtures are attached.

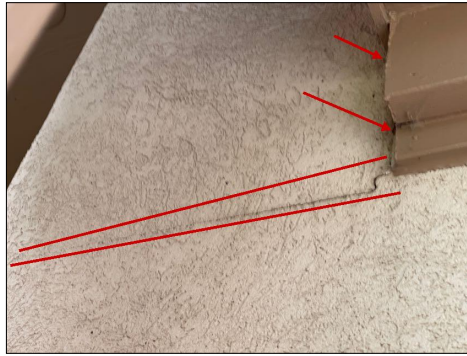
The EIFS surface at the north side at the front porch has a horizontal crack at the bottom soffit area. No moisture detected surface should be sealed.

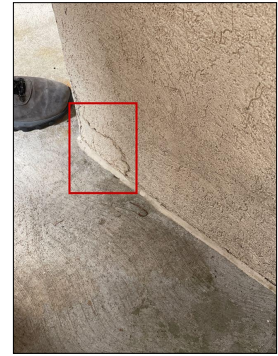
The EIFS at the front porch northside just above the concrete surface is cracked and should be sealed.

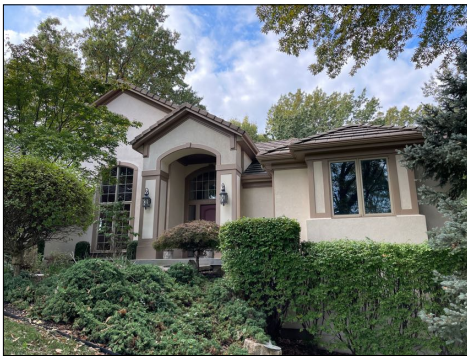
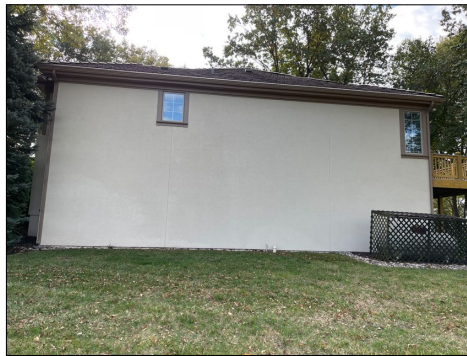
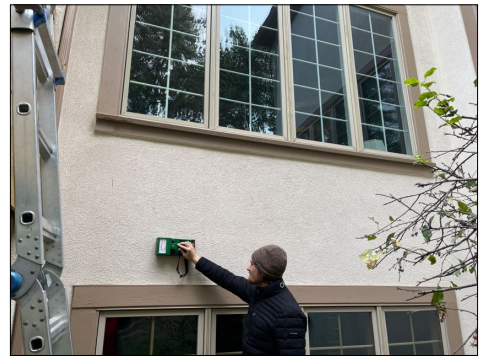
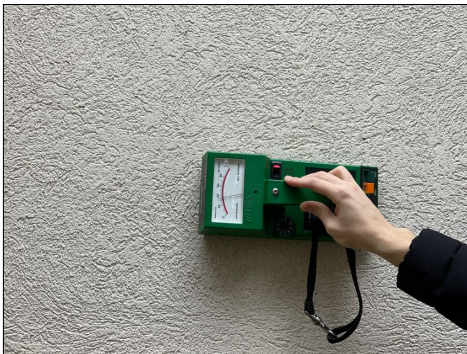
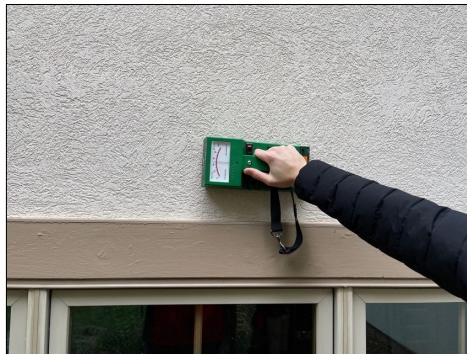
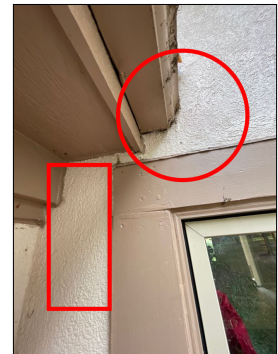
On the exterior west side of the living room above the north side windows there is a gutter there is excessive moisture content at the gutter area and below the soffit proximately 12 inches.

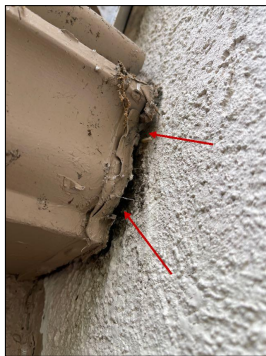
The synthetic stucco mesh is visible at the end of the gutter above the living room exterior above the North side of the window. This may be where the moisture is getting in behind the surfaces.

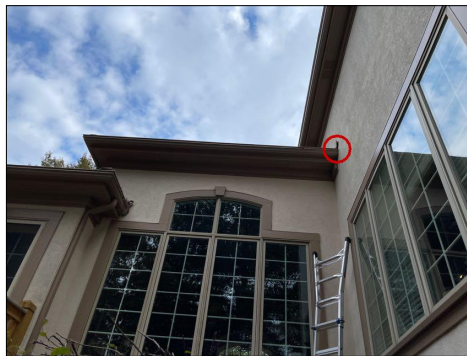
Living room area. West side above the living room south side windows at the gutter running north to south, the kick out flashing was not installed properly and there is visible EIFS Base Coat Mesh at the end of the guttering.

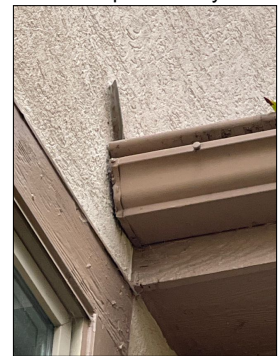
West side above the air conditioning condensers at the lower gutter running west to east, at the east end of the guttering the synthetic stucco mesh is visible and they kick out flashing was not properly installed.

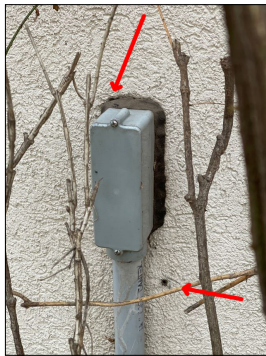
On the west side south of the air conditioning condensers, there's electrical conduit that needs to be sealed up and there's also screw hole that needs to be sealed.

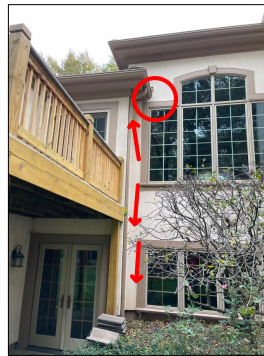
On the exterior west side of the living room above the north side windows, there is a gutter and there is excessive moisture content at the gutter area and below the soffit approximately 12 feet (basement foundation sill plate). The EIFS BASE COAT mesh is visible at the end of the gutter above the living room exterior above the North side of the window. This may be where the moisture is getting in behind the surfaces. There was high moisture content all the way down to the basement. There's also evidence of water intrusion and Mold Growth on the interior basement surfaces on the exterior wall sheathing and wall cavity.

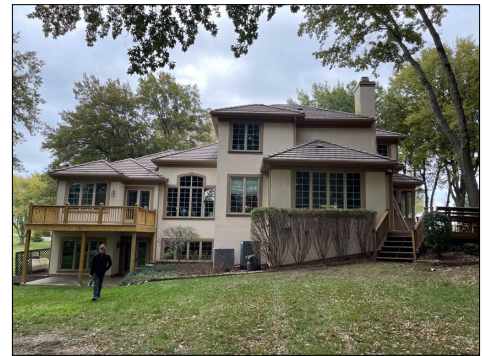
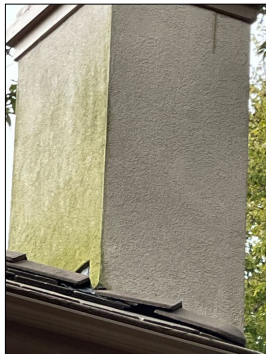
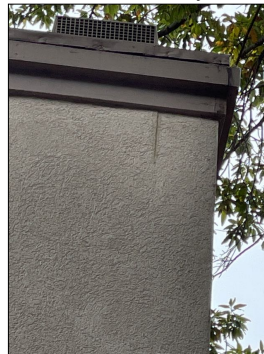
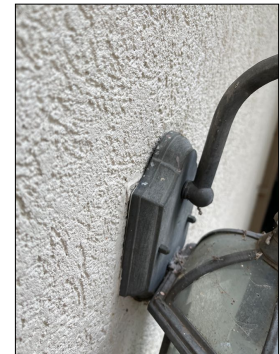
All exterior light fixtures need to be caulked how long the top and sides of the fixtures.

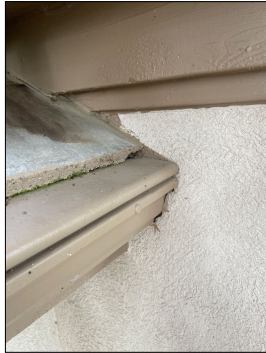
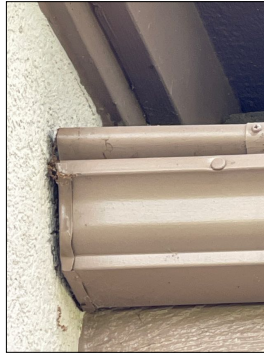
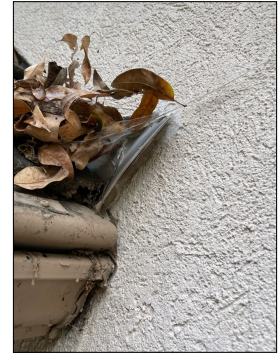
Missing Kick Out Flashing's need to be installed at: Both sides of the garage east bay window area

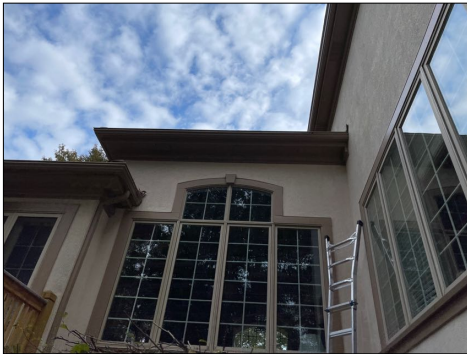
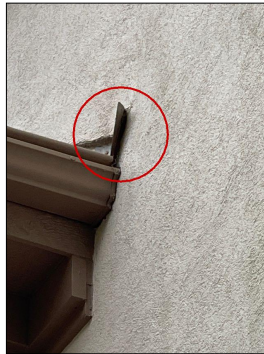
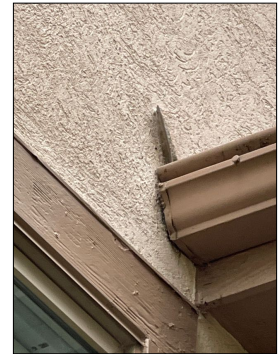
West side above the living room south side windows at the gutter running north to south, the kick out flashing was not installed properly and there is visible EIFS Base Coat Mesh at the end of the guttering.

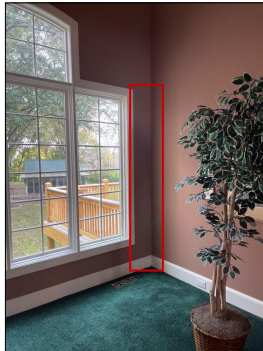
LR NW corner drywall, baseboard trim and probably wall insulation needs to be removed for mold remediation. Mold growth noted behind the west baseboard trim and baseboard trim is swollen.

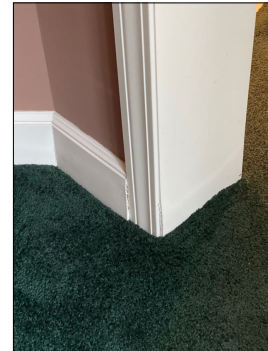
Doorway between the LR and Kitchen has water damage at the east side door casement trim and both sides at the baseboard trim. Removal needed for mold remediation as needed.

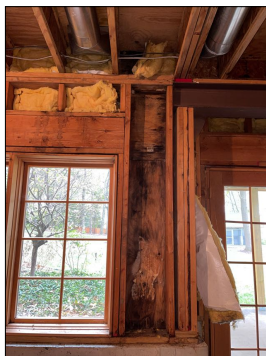
Mold growth is visible in the basement on the exterior wall sheathing at the southside of the exterior pedestrian doors. This is from water intrusion from above the northside living room windows area.

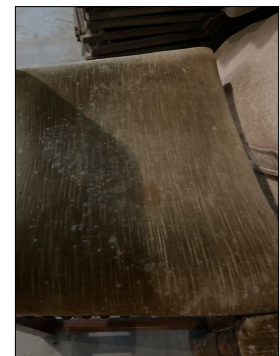
There is mold grow throughout the basement on furniture and other personal items due to elevated humidity.

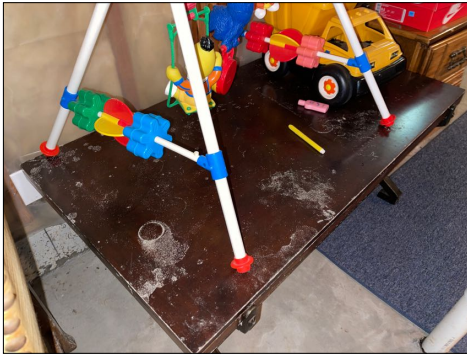
There is mold grow throughout the basement on furniture and other personal items due to elevated humidity.

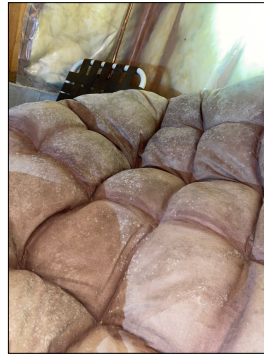
There is mold grow throughout the basement on furniture and other personal items due to elevated humidity.

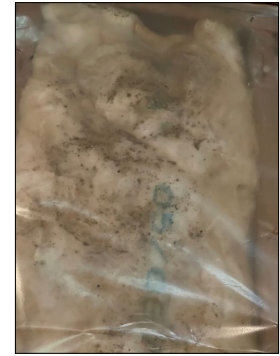
There is mold growth between the exterior wall insulation and vapor barrier in the basement due to elevated humidity.

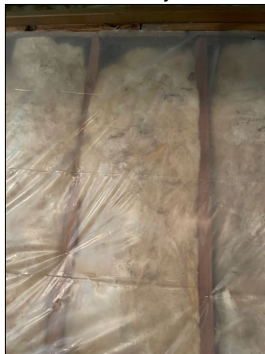
There is mold growth between the exterior wall insulation and vapor barrier in the basement due to elevated humidity.

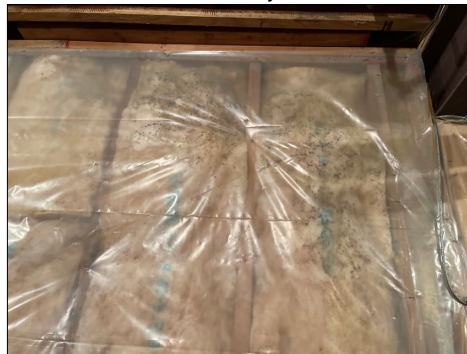
There is mold growth between the exterior wall insulation and vapor barrier in the basement due to elevated humidity.

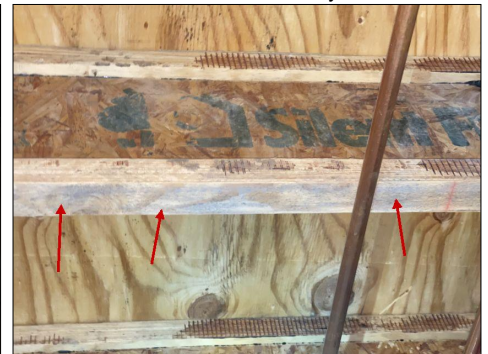
Mold growth along the bottom of several floor joists in the basement
