# RC Certified Inspections

**Comprehensive Structural & Mechanical Property Inspections**

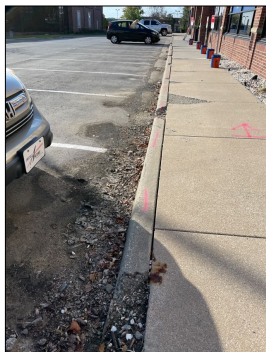
Poured Concrete Curb At front sidewalk area.

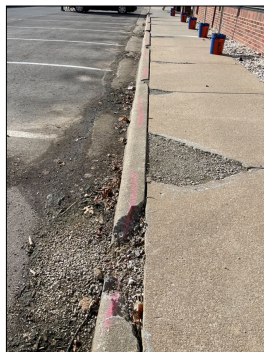
The front concrete curb along the sidewalk is broken up and deteriorated the entire length and needs to be replaced.

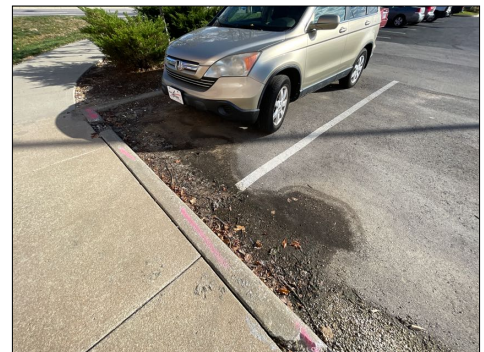
Water is sitting along the front of the building at the concrete curb area due to the parking lot sloping towards the curb.

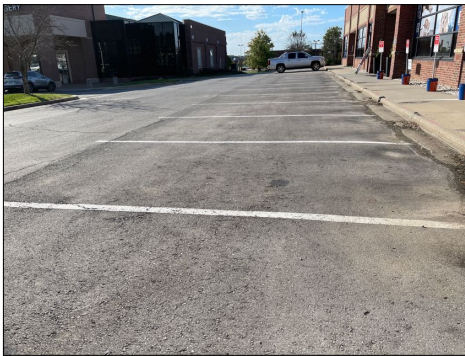
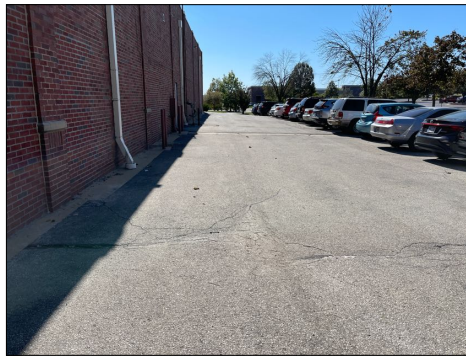
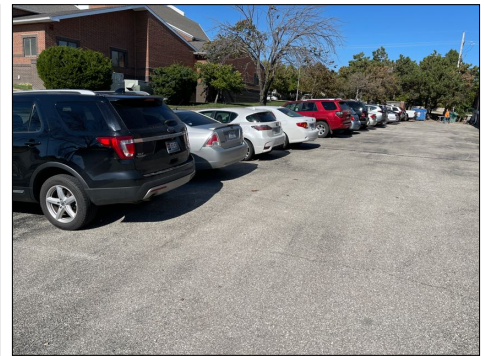
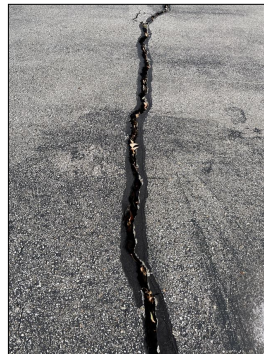
Rear parking Drive area west side towards the south west corner has a large opening in the asphalt that needs to be filled in to help prolong life and prevent tripping hazards.

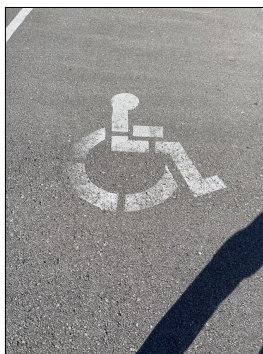
It is recommended that the handicap parking lot striping to be re-striped. They are faded and should be corrected.

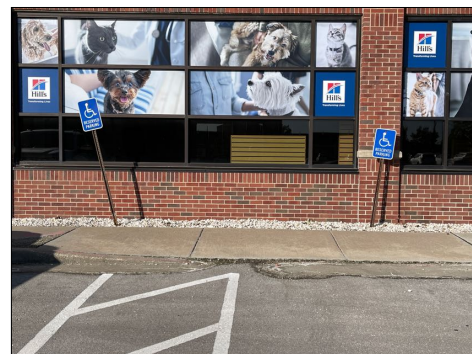
The Handicap signs are missing or damaged. Corrections required. Both signs need to be reset. They are very loose and ready to fall over.

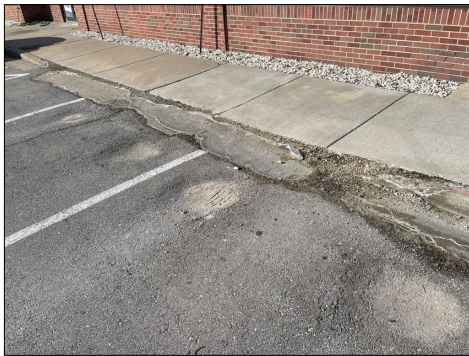
The sidewalk handicap ramp area is completely deteriorated.

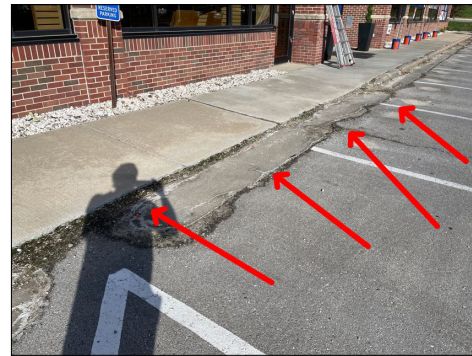
The sidewalk handicap ramp area is completely deteriorated.

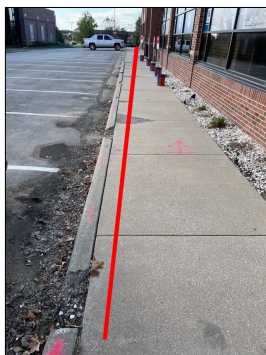
Tripping hazard(s) noted:

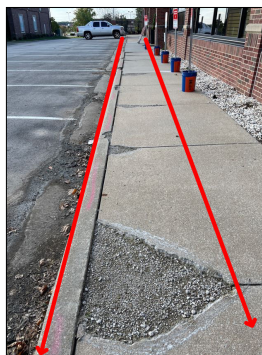
Sidewalk deterioration along the front sidewalk area.

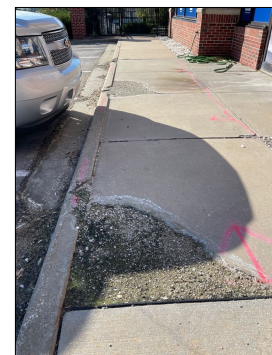
Sidewalk deterioration along the front sidewalk area.

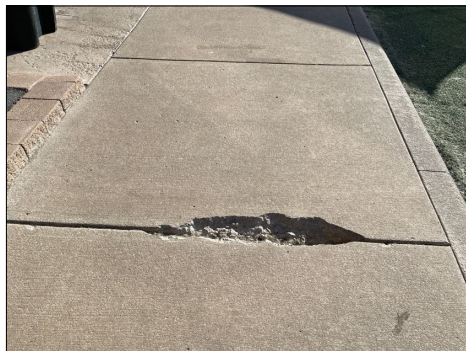
Southside sidewalk at Pet exterior play area is a large opening and is a tripping hazard.

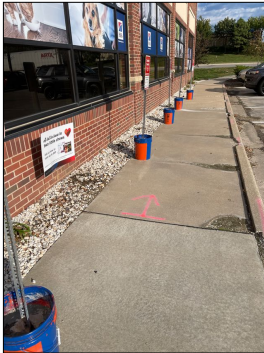
Along the front east side of the building between the brick foundation and sidewalk area is soil with no evidence of drainage. This is keeping water trapped between the sidewalk and the brick surfaces.

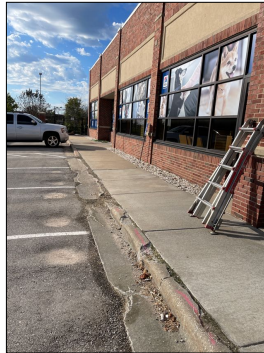
Along the front east side of the building between the brick foundation and sidewalk area is soil with no evidence of drainage. This is keeping water trapped between the sidewalk and the brick surfaces.

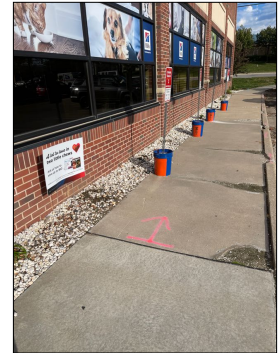
Soil and ground covering must be below the bottom brick surfaces so that water does not become trapped in the brick wall. This is an issue all along the building.

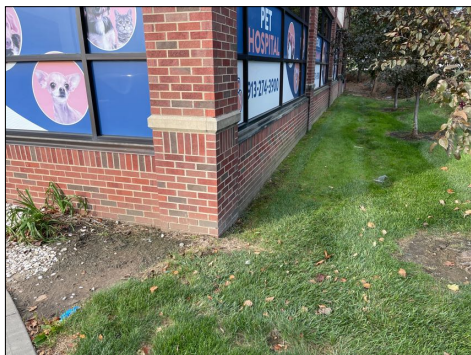
Soil slope and drainage within 5' of the foundation is inadequate and needs to be corrected. The soil needs to be sloped and compacted at a 5 degree slope outward from the foundation. This is a 1" drop per foot out to 5', which is equal to a 5" drop at 5' out from the foundation. Keep the soil and ground covering at least 6" below any siding, trim, window openings or foundation vents (where applicable). Negative soil slope towards the foundation can cause foundation damage, basement slab heaving and cracking, water intrusion and mold. Negative soil slope with mulch holds more water against the foundation. This must be corrected and maintained! \*\*

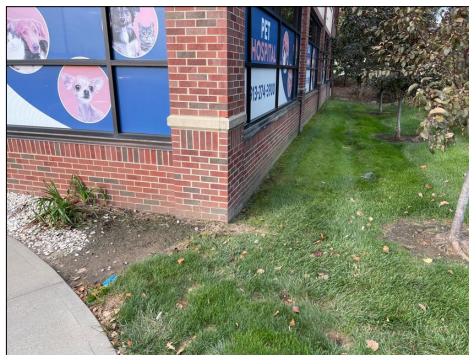
Soil and ground covering must be below the bottom brick surfaces so that water does not become trapped in the brick wall. This is an issue all along the building.

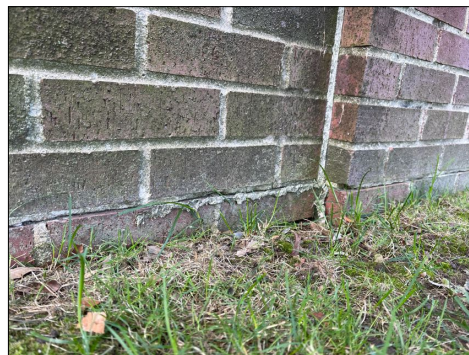
On the north side of the building where the soil and poor drainage is against the brick and higher than the bottom of the brick, the bottom rows of the brick shows evidence of mortar joint separation. Soil needs to be lowered in the brick mortar joints repaired.

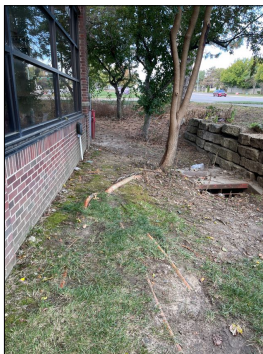
Trees are within 6 feet of foundation. Monitor for potential root damage. Recommend removal. Referral: Bill Edington, D&B Tree Service at (913) 206-1533.

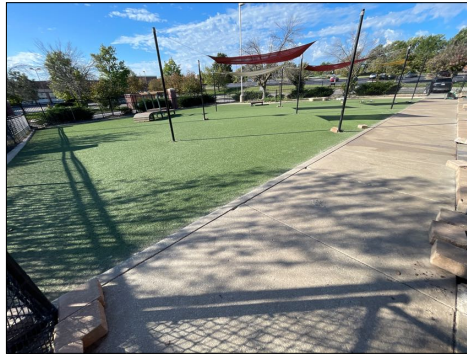
### 8. Main Gas Meter/Valve Condition

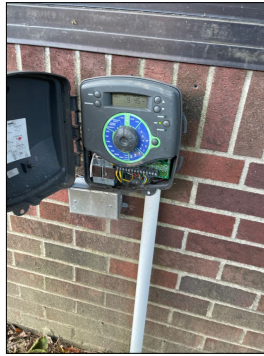
The sprinkler system control panel is located On the exterior northside north west corner.

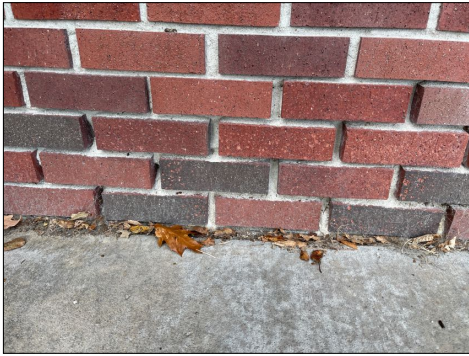
There are several areas of the exterior brick where the mortar is deteriorated and needs to be cleaned up and tuck pointed.

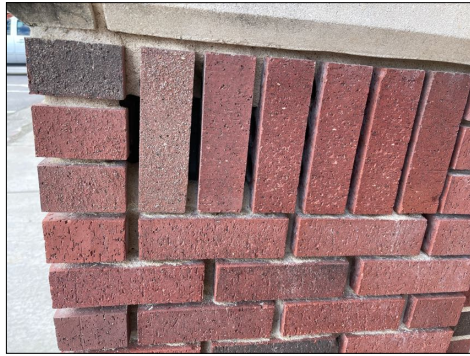
There are several areas of the exterior brick where the mortar is deteriorated and needs to be cleaned up and tuck pointed.

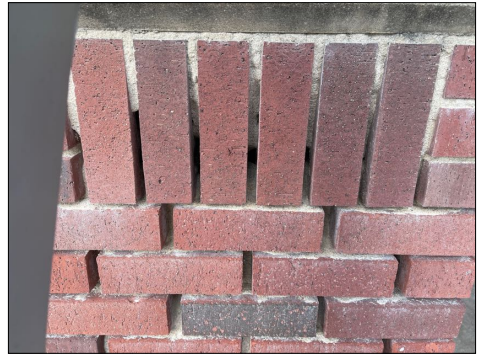
There are several areas of the exterior brick where the mortar is deteriorated and needs to be cleaned up and tuck pointed.

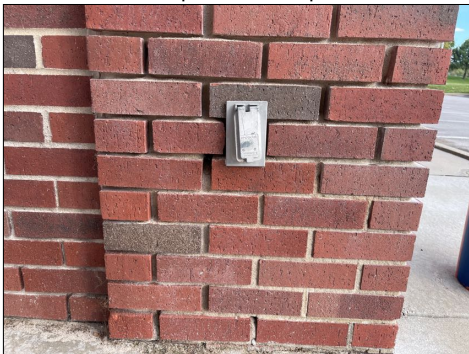
There are several areas of the exterior brick where the mortar is deteriorated and needs to be cleaned up and tuck pointed.

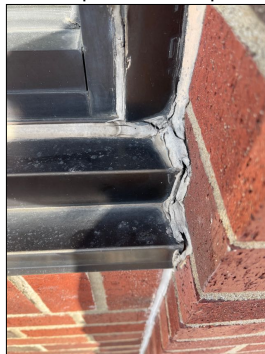
Exterior store front windows and bottom sill trim areas have sealant that is missing or opened. Need to clean up these areas and reseal.

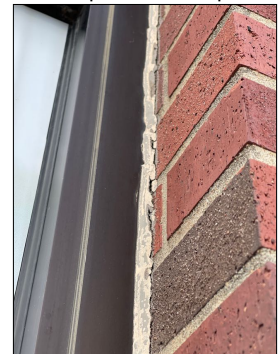
Caulk where Trim meets Siding, Stucco, Brick, Etc.

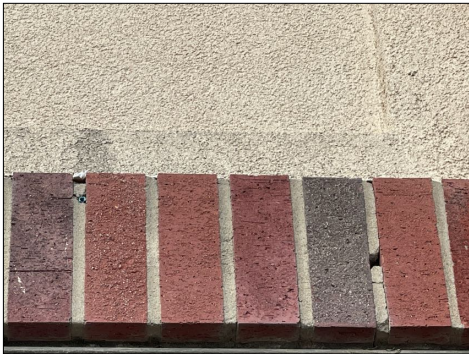
There are several areas of the exterior brick where the mortar is deteriorated and needs to be cleaned up and tuck pointed.

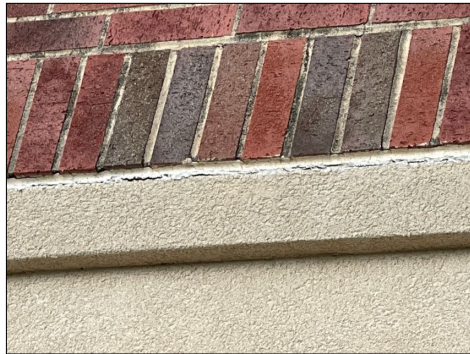
Caulk where Trim meets Siding, Stucco, Brick, Etc.

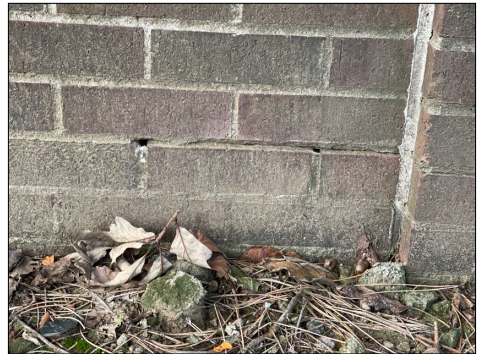
There are several areas of the exterior brick where the mortar is deteriorated and needs to be cleaned up and tuck pointed.

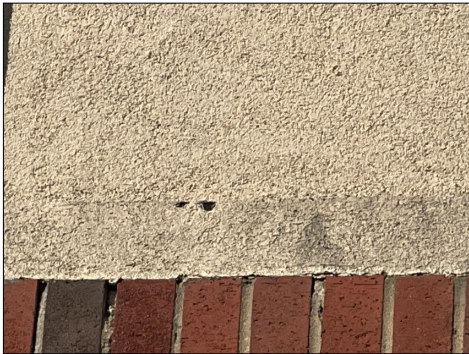
There are areas of the front drivit stucco material That has holes to the surfaces that needs to be repaired. Check all incorrect as needed.

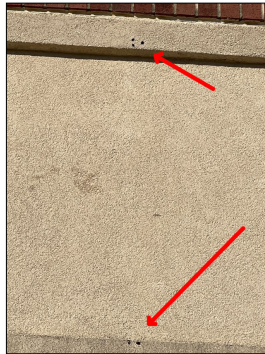
There are areas of the front drivit stucco material That has holes to the surfaces that needs to be repaired. Check all incorrect as needed.

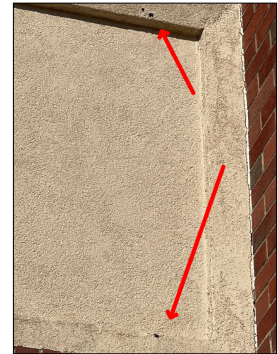
There are areas of the front drivit stucco material That has holes to the surfaces that needs to be repaired. Check all incorrect as needed.

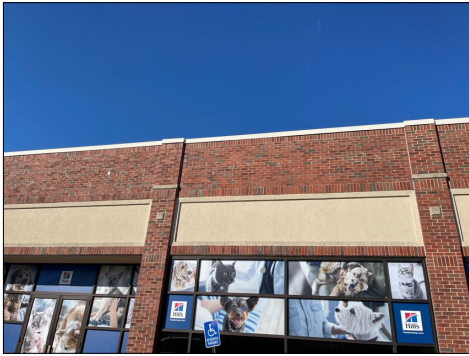
There are areas on the front of building at the upper brick where it looks like there has been signs installed and there are holes in the surface of the brick and mortar that should be sealed or tuck pointed.

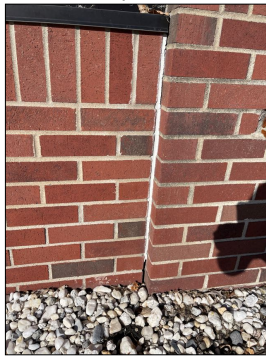
There are a few vertical brick joints that the sealant is deteriorated. Need to clean out these areas and apply new sealant.

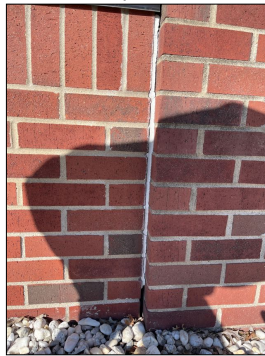
There are a few vertical brick joints that the sealant is deteriorated. Need to clean out these areas and apply new sealant.

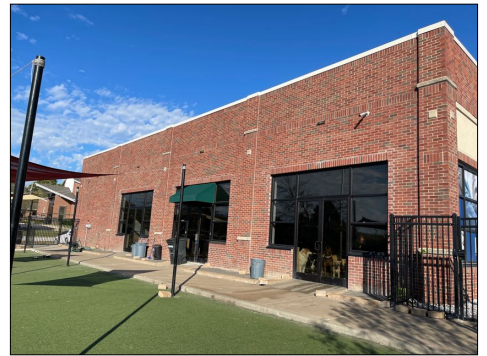
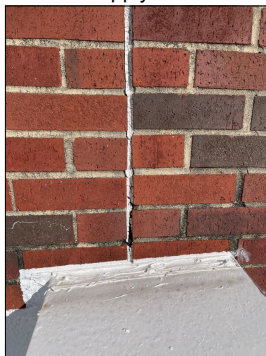
There are a few vertical brick joints that the sealant is deteriorated. Need to clean out these areas and apply new sealant.

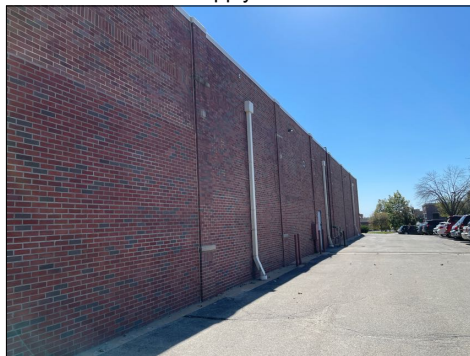
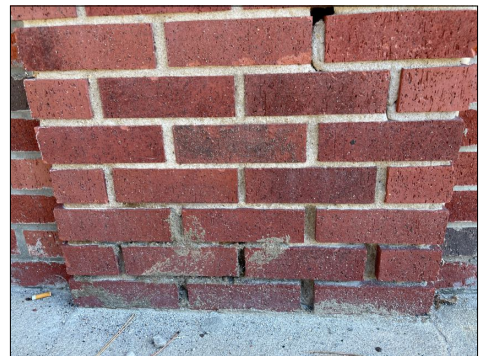
There are several areas of the exterior brick where the mortar is deteriorated and needs to be cleaned up and tuck pointed.

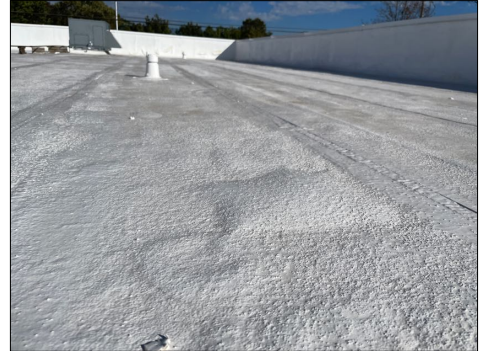
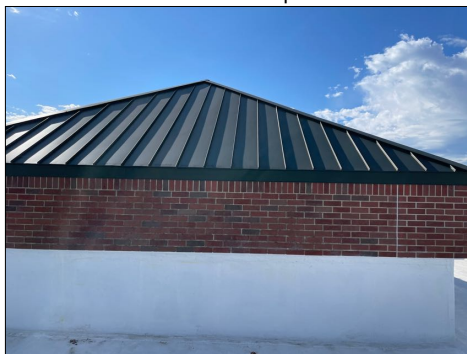
Metal standing seam roofing noted. Over front center area.

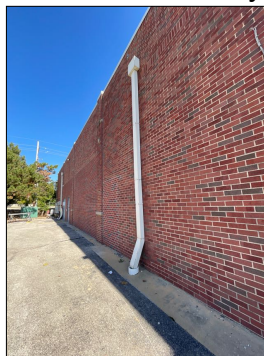
9.2. Underground drain pipes are installed. They should always empty at least 10 feet out from the foundation. During the home inspection, we do not verify if the pipes are draining properly and or where they do daylight. Either check with the Seller or they should be tested.

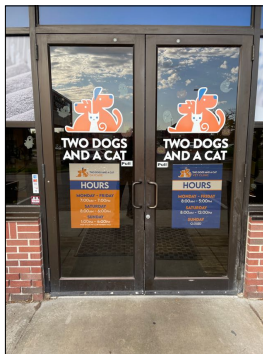
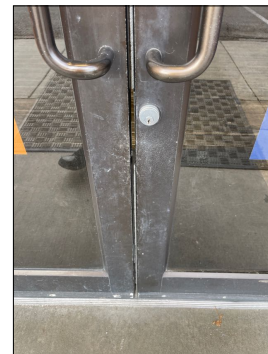
Need to install new door casement weatherstrips due to damage and/or current ones don't seat at the threshold and/or not properly fitted at the upper corners. Large gaps noted between the two doors.

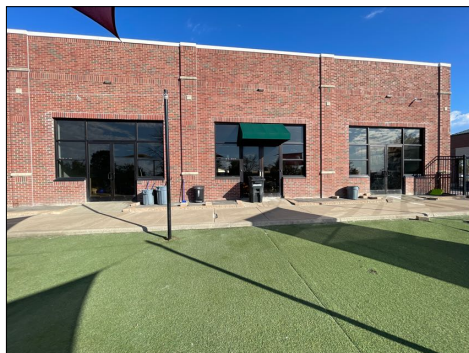
Commercial Grade Metal Double Doors with GLASS: 3- Sets on the South side of the building.

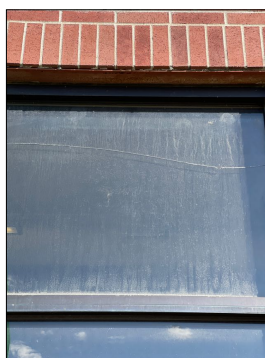
Window Pane Glass is Cracked/Broken at: Center exterior doors above it to the east top window.

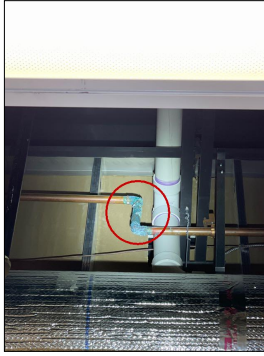
Evidence of leaking pipe in south boarding room east wall above the 3rd dog pin

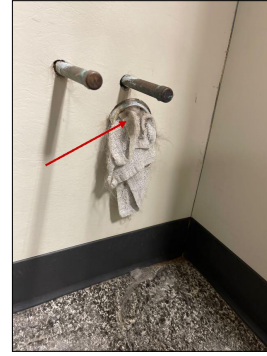
Grooming room east wall north end has a drain pipe that was not capped off properly.

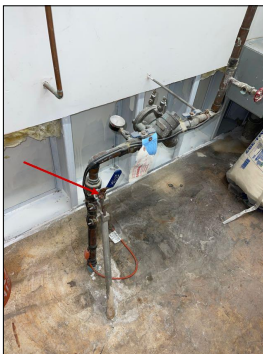
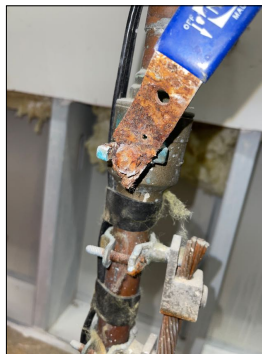
Shut off valve is very rusted. Recommend replacing

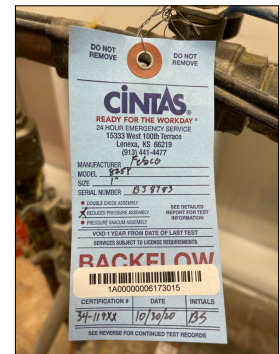
### 3. Waste Disposal

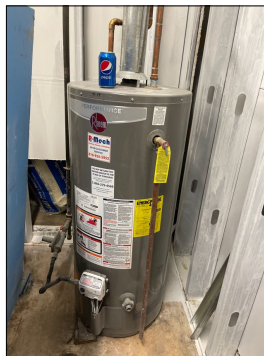
### 2. Water Heater Flue

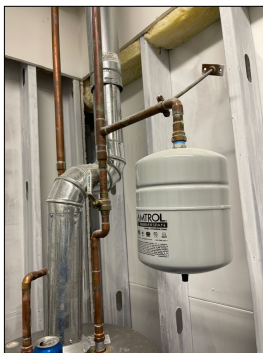
# North Tankless Water Heater

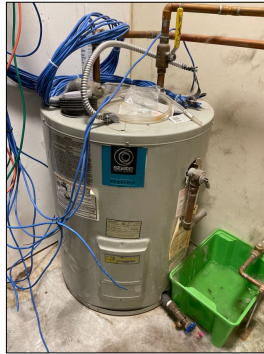
# South Family Bathroom

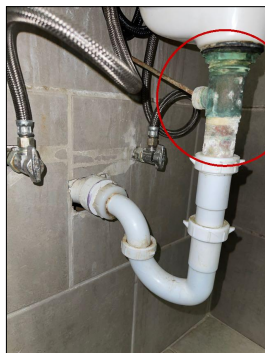
Sink copper drain tailpiece has evidence of corrosion and needs to be replaced.

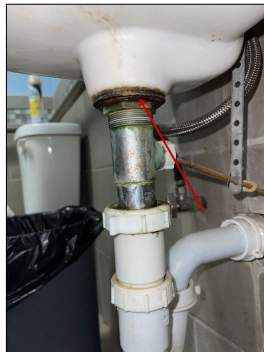
Evidence of a leak at the sink flange

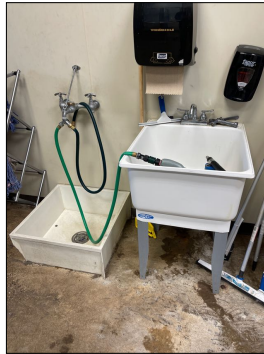
## Boarding West 1/2 Bath (continued)

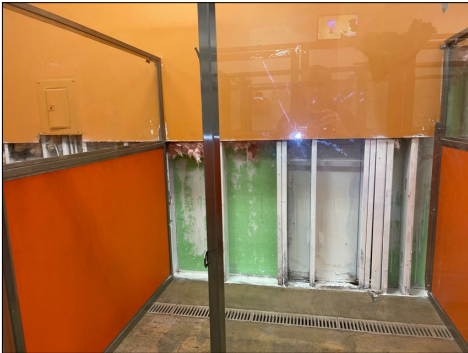
Orange wall mold growth found Above wall cut out where the electric panel is located and the kennel to the north of it.

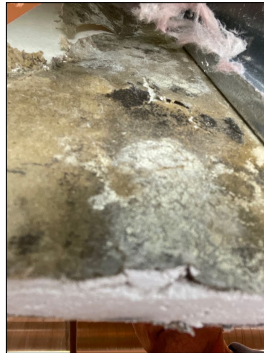
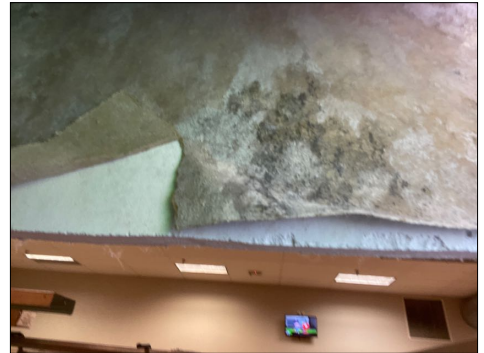
Orange room west wall mold growth above wall cut out at the higher wall cut out areas.

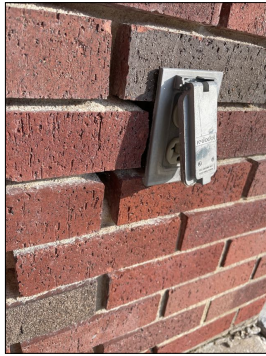
The Exterior Receptacle Cover is Damaged at: Front entrance,

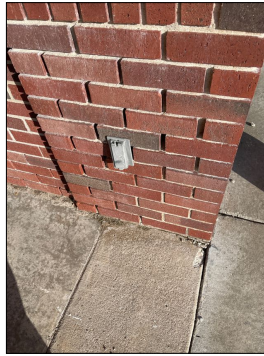
The receptacle at the front entry was dead at the time of the inspection. There may be a GFCI receptacle on the interior.

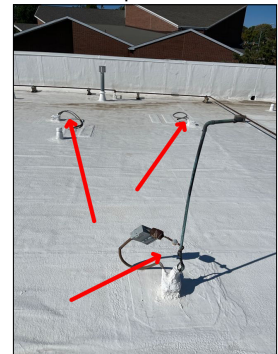
There are three unused old HVAC electrical systems at the center west side area. The lines appear to be dead. Recommend verification and disconnect and clean up of these systems.

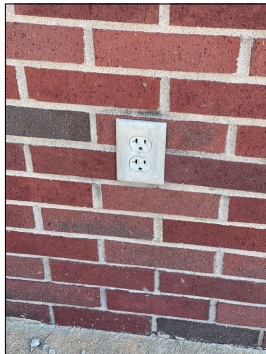
Exterior west side at the center of the building is an electrical receptacle that is dead plus it does not have an exterior cover installed.

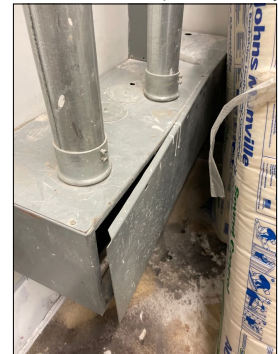
In the west electric panel room where the main water shut off valve is located, just to the north side is an electrical race and the cover is loose leaving the interior wiring exposed and Unsafe. There are also missing knockout plugs that needs to have plugs installed.

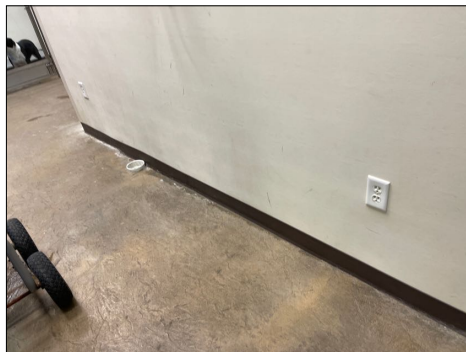
All of the wall receptacle outlets in the kennels should have exterior waterproof covers on it since the floors in the areas get sprayed down with water.

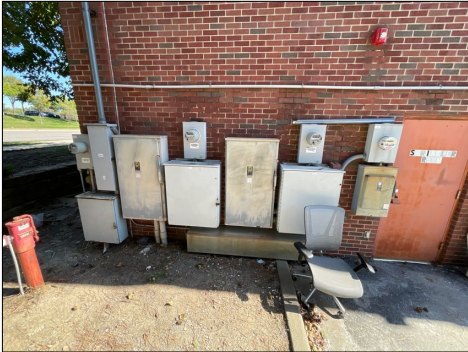
4- Electric Meters, Only 3- Exterior Main Disconnects noted and the South 200amp Disconnect is OFF.

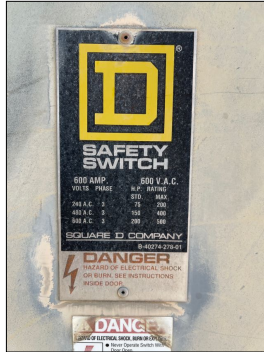
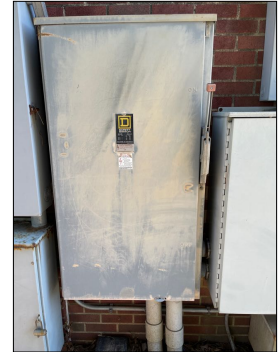
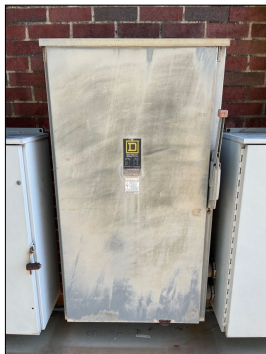
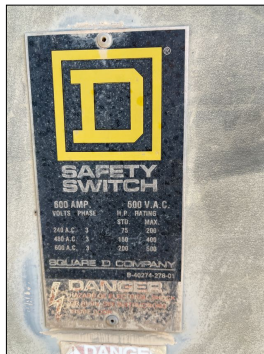
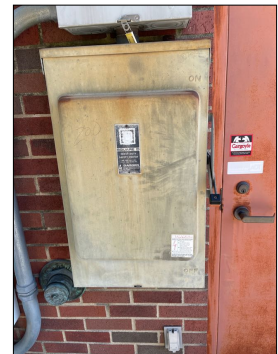
# ELECTRICAL SYSTEM (continued)

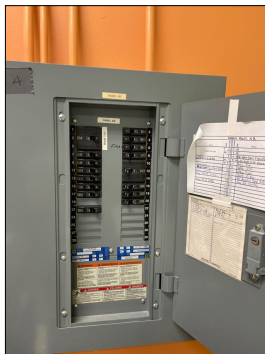
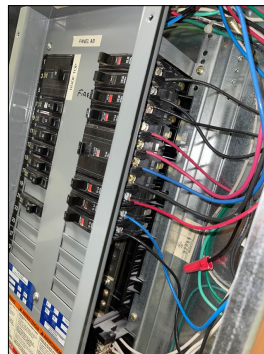
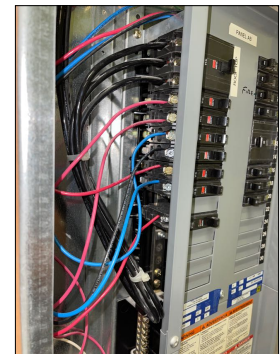
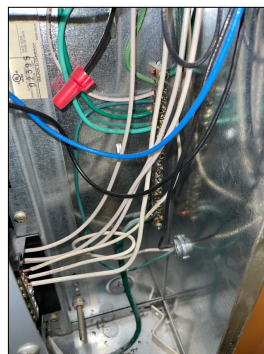
## 2. Main Disconnect Amps

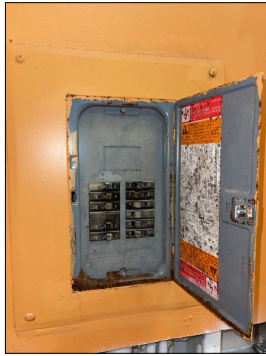
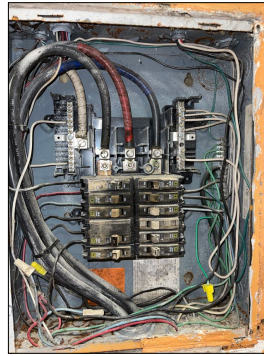
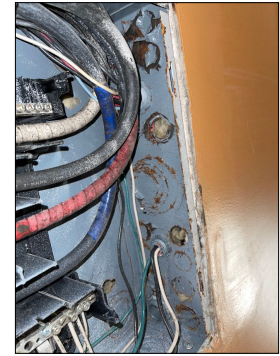
Missing Knockout(s) Plugs need to be installed to keep mice out of panel box and to avoid potential electrocution hazard and to contain any possible sparks or fire from exiting into the wall cavities:  
top of panel

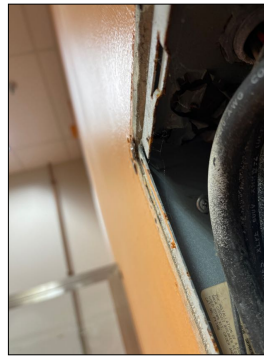
### 2. Main Disconnect Amps

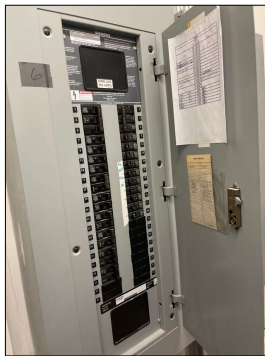
| PANEL 6 | | | |

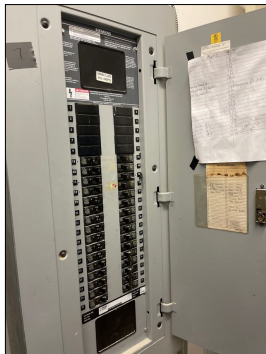
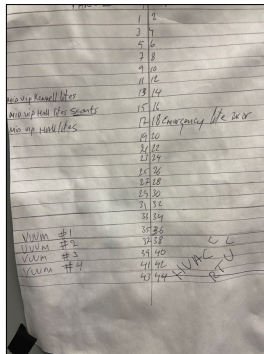
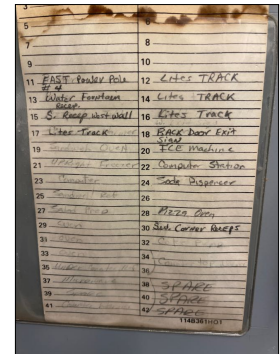
## PANEL 7 - West Rm (continued)

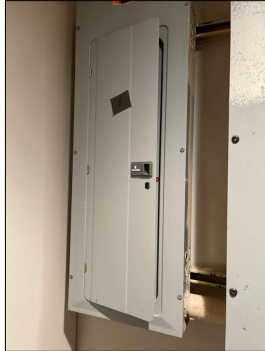
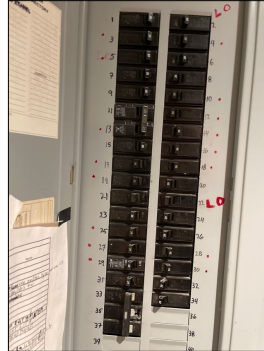
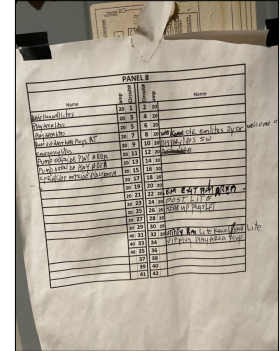
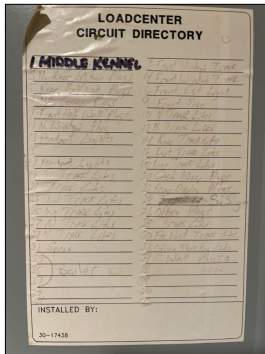
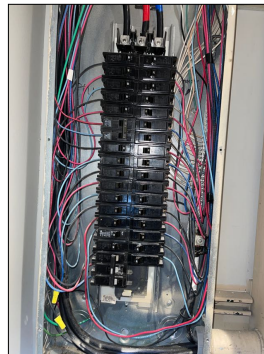
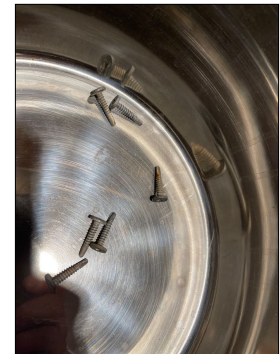
Sharp-pointed metal screws are holding the panel cover in place. These are a potential hazard as they may puncture wire insulation and electrify panel box, becoming a shock or electrocution hazard. These screws need to be replaced with approved, flat-tipped screws.

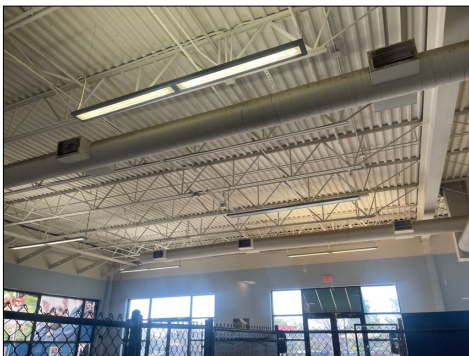
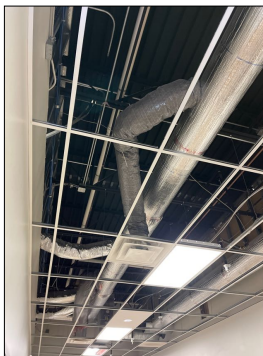
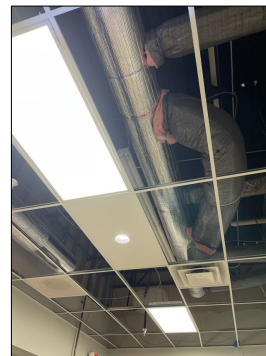
### 3. Registers/Vents

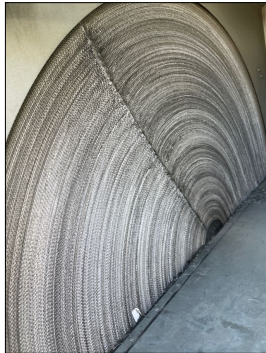
The circular rotating fins are badly damaged because of air filters being loose and laying up against the surfaces on both sides. Complete evaluation required.

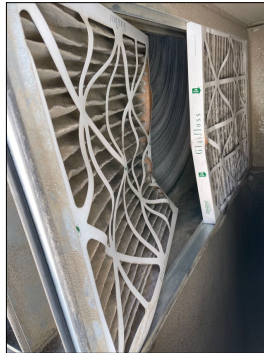
The circular rotating fins are badly damaged because of air filters being loose and laying up against the surfaces on both sides. Complete evaluation required.

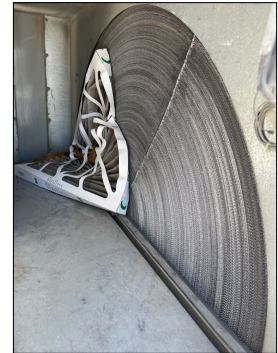
The circular rotating fins are badly damaged because of air filters being loose and laying up against the surfaces on both sides. Complete evaluation required.

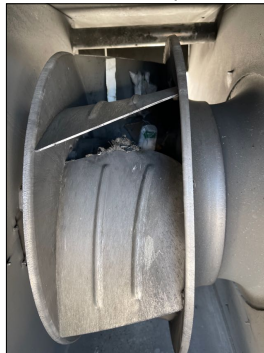
There is debris in the rotating fan blades.

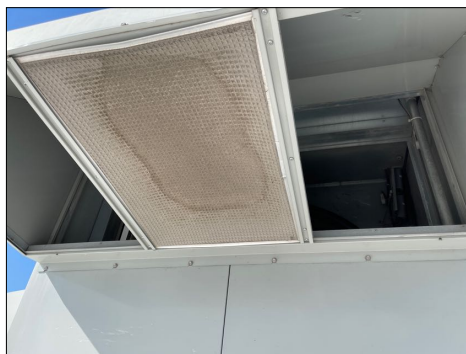
There are three prefilters on the exterior and two of them are missing and the one present is very dirty.

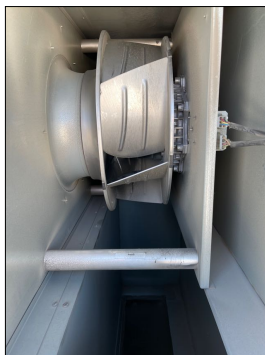
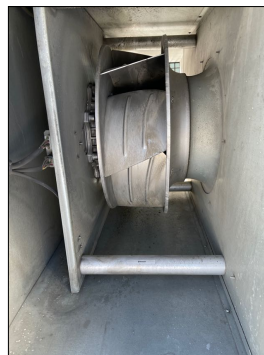
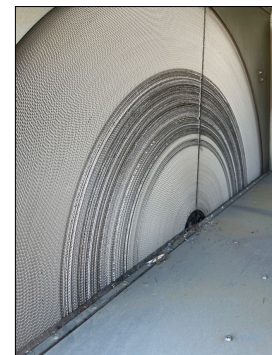
Rotating wheel with fins has some damage on the west side. Doesn't appear to be an issue at this time but could restrict some airflow.

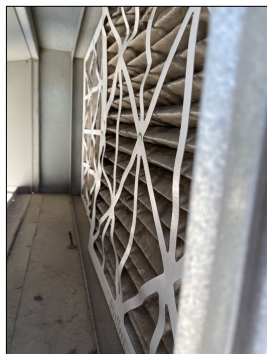
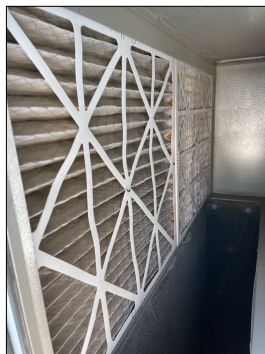
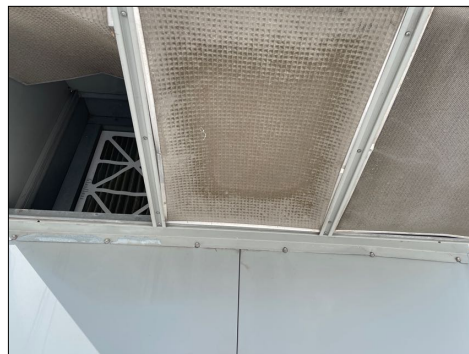
One of the prefilters are missing.

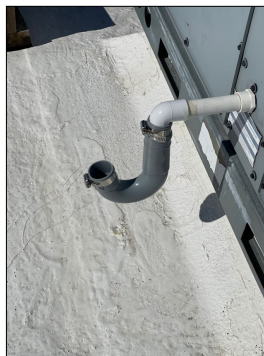
The air conditioning condensation drain needs to be extended to the west roof drain.

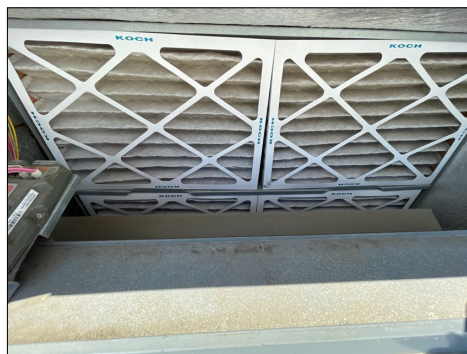
4.1. Air filter needs to be replaced now.

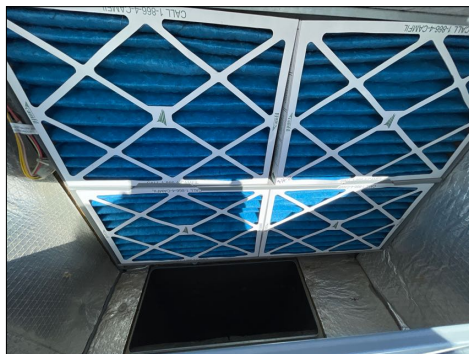
## Daikin North Unit (continued)

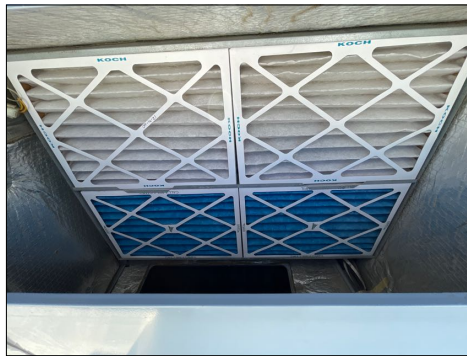
4.1. Air filter needs to be replaced now.

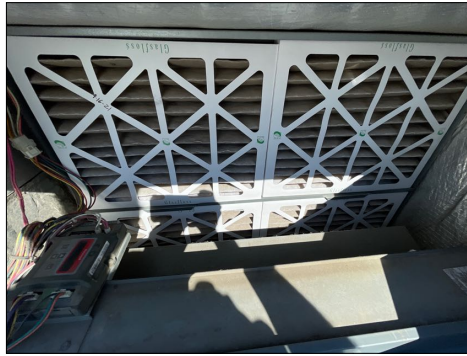
## Daikin Center-North Unit (continued)

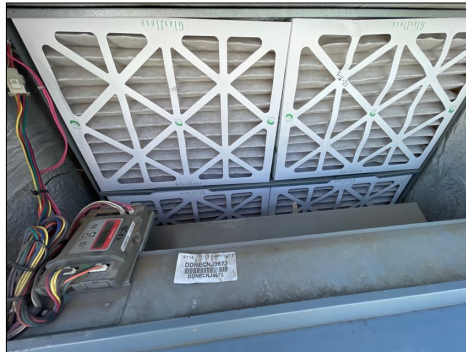
- 4.1. Air filter needs to be replaced now.

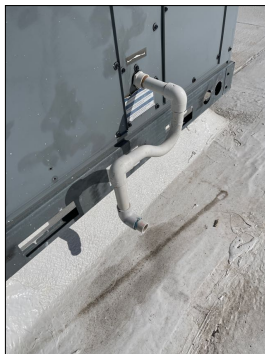
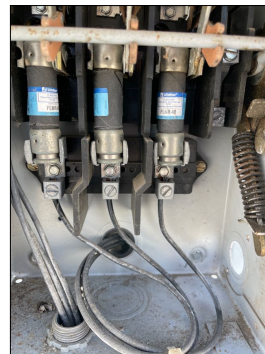
Air conditioning condensation drain needs to be extended to the west side roof drain.

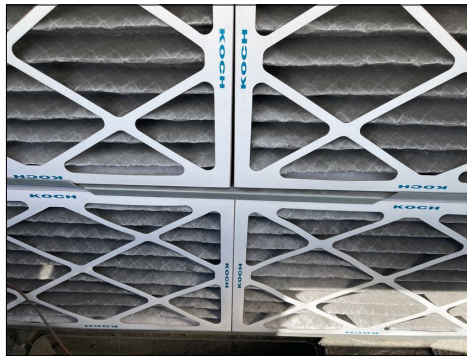
4.1. Air filter needs to be replaced now.

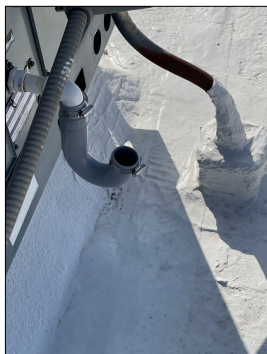
Air conditioning condensation drain line needs to be extended to the west roof drain.

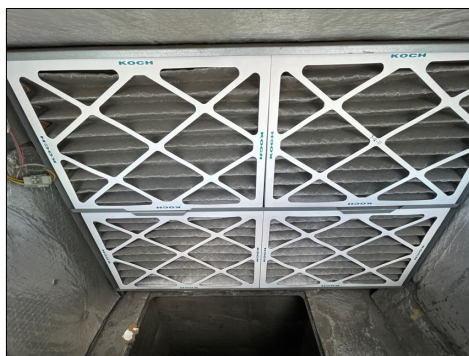
3.1. Air filter needs to be replaced now.

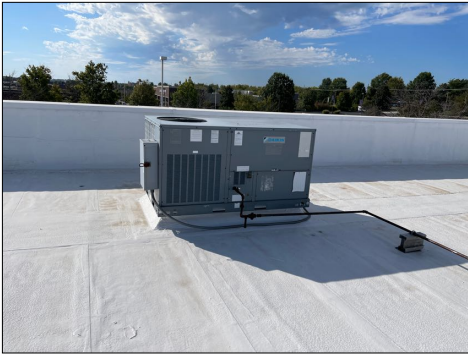
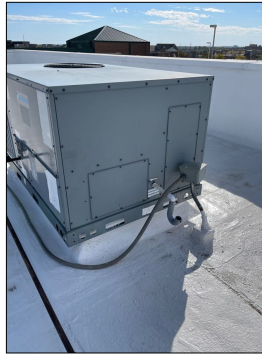
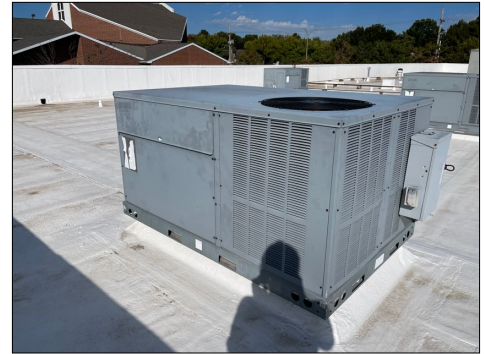
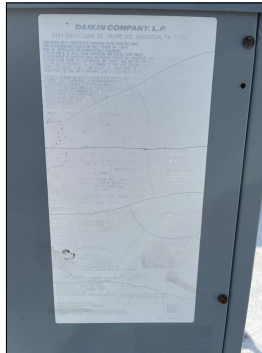
## 2. Furnace/Heater

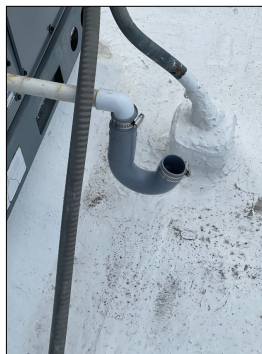
The air conditioning condenser drain line needs to be extended to the west side roof drain.

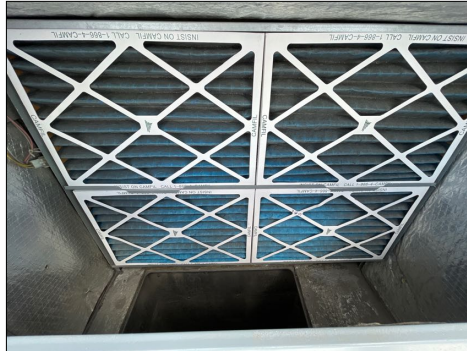
4.1. Air filters Are marked that they were replaced October 16, 2021 but they sure look like they've been in there a lot longer and is recommended to be replaced now.

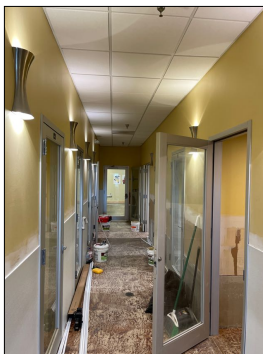
### 2. Electrical Safety-Defects

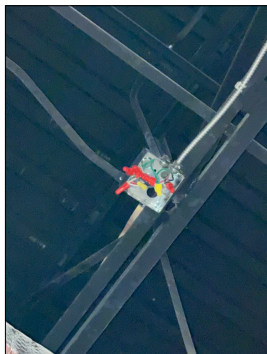
Junction Boxes missing either Cable Connectors, Cover or Knock-Out Plugs at: east side above 3rd room from south

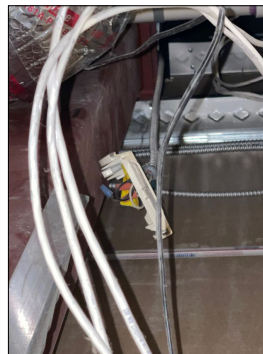
Junction Boxes missing either Cable Connectors, Cover or Knock-Out Plugs at: above west side sw corner room

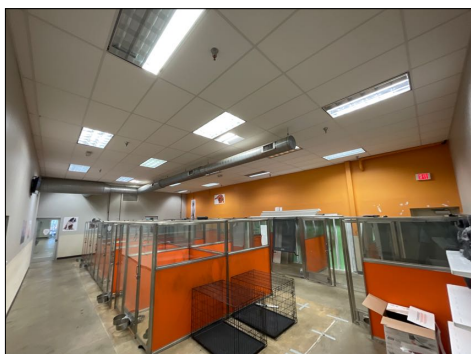
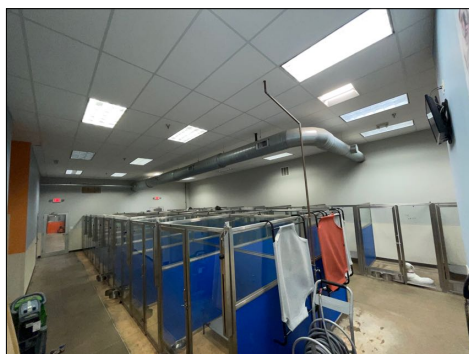
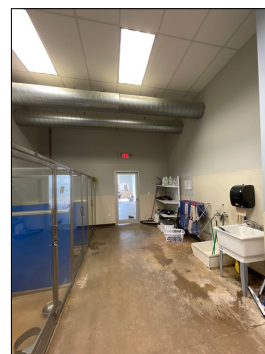
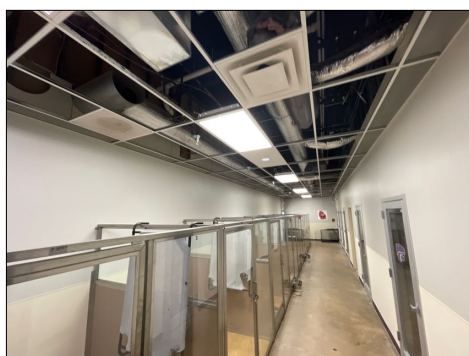
## 2. Electrical Safety-Defects

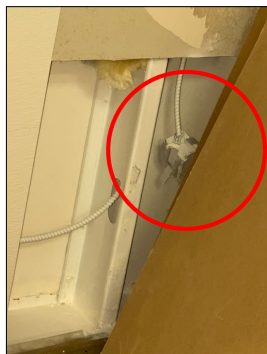
Hanging junction box: West boarding 2nd room from south NW corner

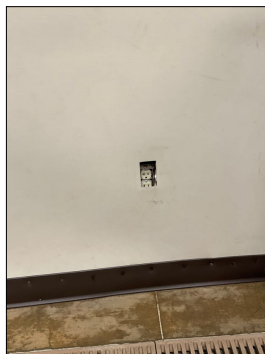
Missing or Damaged Receptacle Covers at: west boarding east wall 2nd dog pin from north

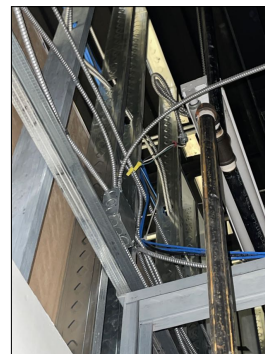
There are spliced electrical circuit wiring that must be in proper junction boxes with cable connectors and cover at: ceiling above south boarding 3rd room from west boarding room

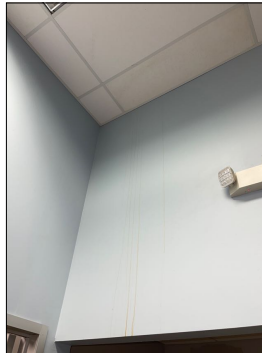
There is evidence of moisture intrusion noted. We are recommending water intrusion investigation. Water intrusion could develop mold growth on the surfaces. RC Certified Inspections can provide this investigation. Located at: west boarding west wall south end, could be due to older roof

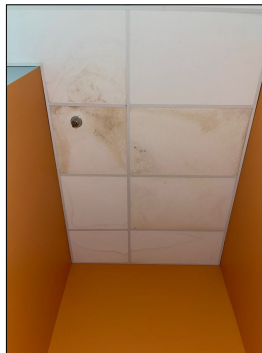
### 5. Doors-Exterior Rear

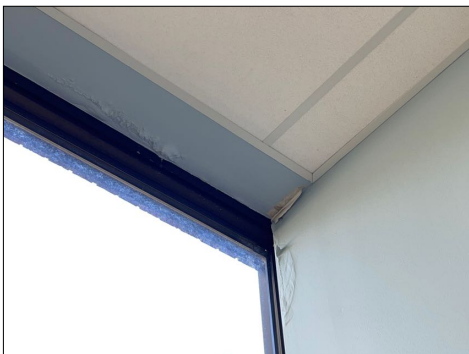
Evidence of water intrusion: above north wall east side windows

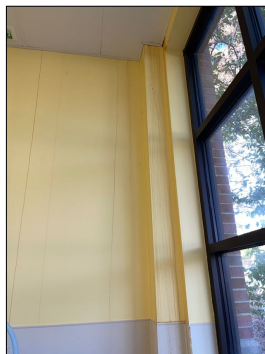
There's brown water staining going down the wall in the north west corner of the Surgery room

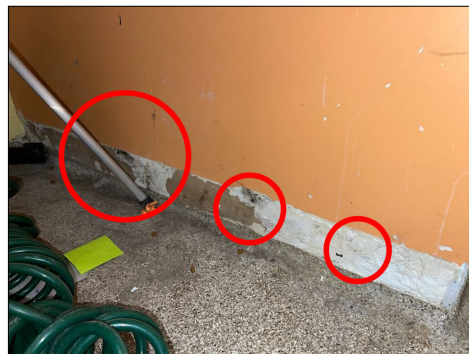
## 2. Ceiling Condition

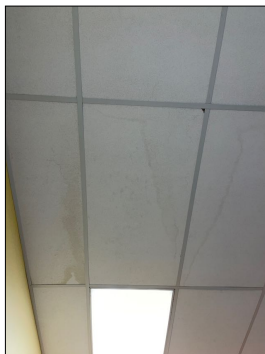
Evidence of Water Stains noted at: above the east door (could be caused by old roof)

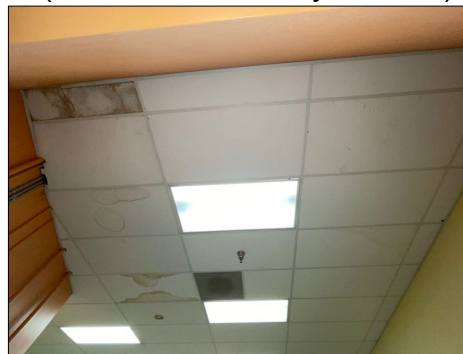
Evidence of Water Stains noted at: multiple stained tiles in X-Ray Room (could be caused by old roof)

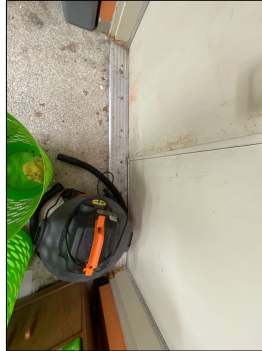
There is Water Damage at the Door Casement and door itself

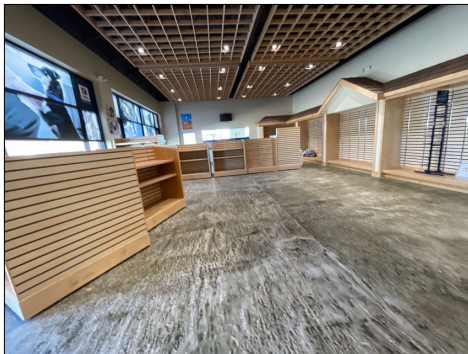
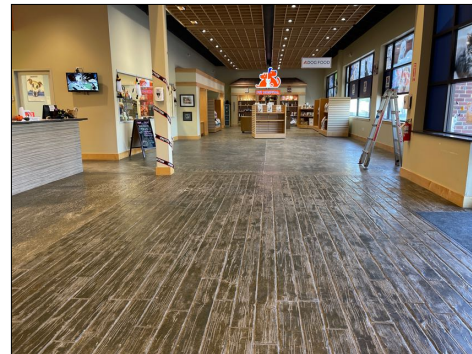
### 2. Window Condition

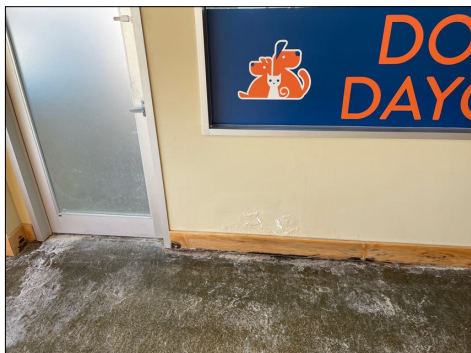
Evidence of a Mold-Like substance present. Mold Testing or Mold Remediation may be required. RC Certified Inspections can provide these services. Also see the MOLD Growth Section in the report. This was found at: along south wall - presumably due to dog pee

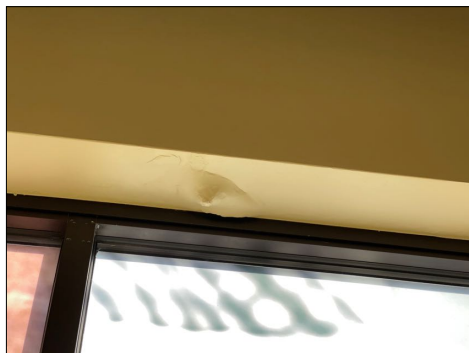
Damaged wall due to water intrusion: North side above the east wall south set of windows

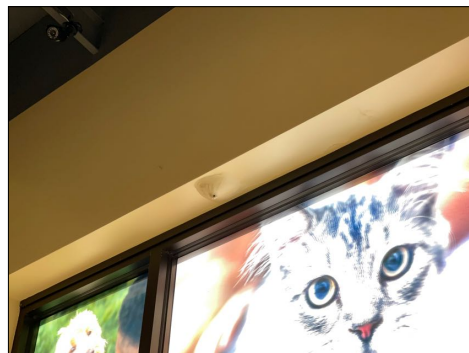
Damaged wall due to water intrusion: North side above the east wall north set of windows

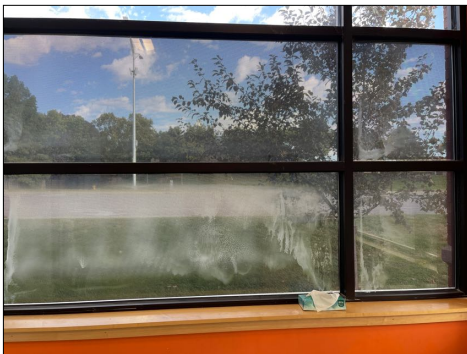
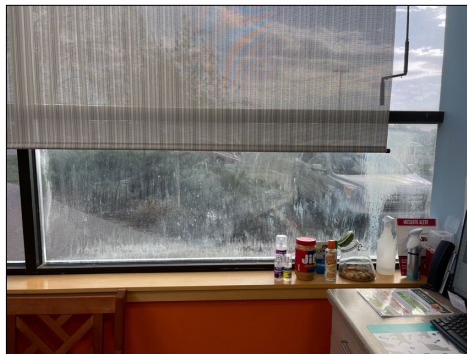
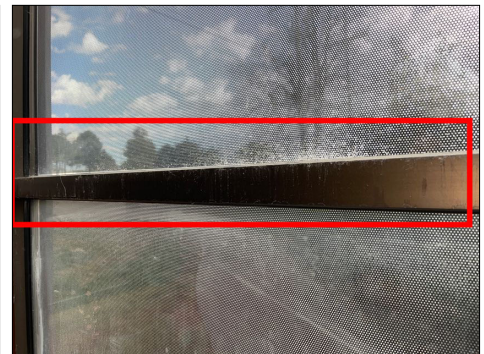
The Window Thermal Pane Integrity shows evidence of failure. The window panes have fogging and condensation between them. They can build enough condensation between the panes to rust through and cause water intrusion into the wall cavity. Recommend further evaluation for needed replacement.

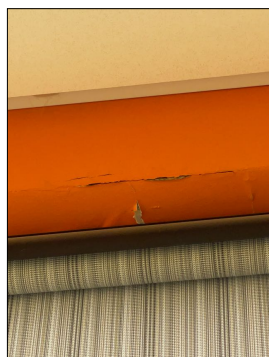
There is evidence of moisture intrusion noted. We are recommending water intrusion investigation. Water intrusion could develop mold growth on the surfaces. RC Certified Inspections can provide this investigation. Located at: East Exam room above windows

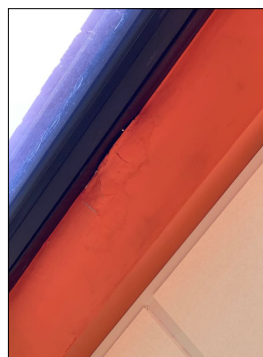
There is evidence of moisture intrusion noted. We are recommending water intrusion investigation. Water intrusion could develop mold growth on the surfaces. RC Certified Inspections can provide this investigation. Located at: north exam room above windows

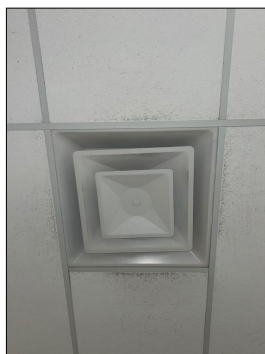
Evidence of Mold-Like substance and further evaluation is recommended. Located: Surrounding west hall supply vent

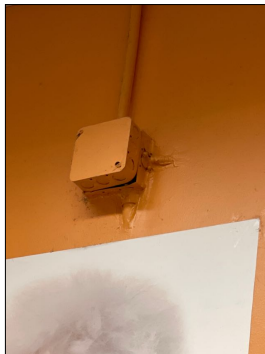
Junction box not sitting flush with second box at: north boarding sw corner west wall

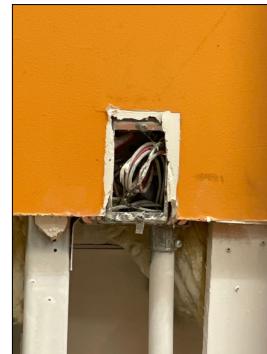
Junction Boxes missing either Cable Connectors, Cover or Knock-Out Plugs at: north boarding west wall south end

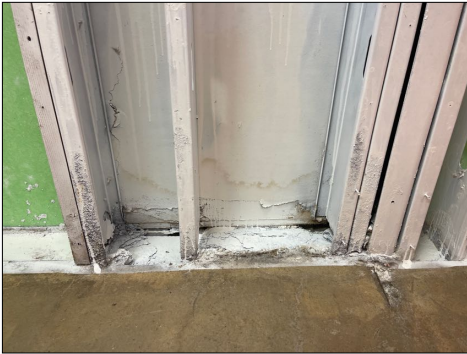
west wall in the north boarding room has water staining at the floor along the white painted walls

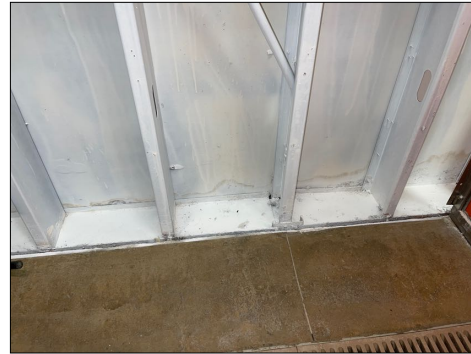
Evidence of a Mold-Like substance present. Mold Testing or Mold Remediation may be required. RC Certified Inspections can provide these services. Also see the MOLD Growth Section in the report. This was found at: found in north boarding room west white walls along floor
