# RC Certified Inspections

**Comprehensive Structural & Mechanical Property Inspections**

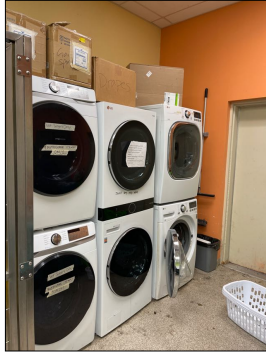
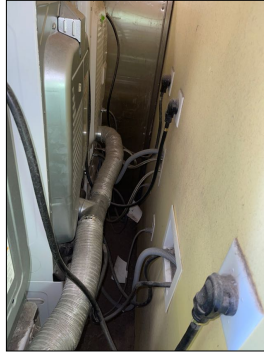
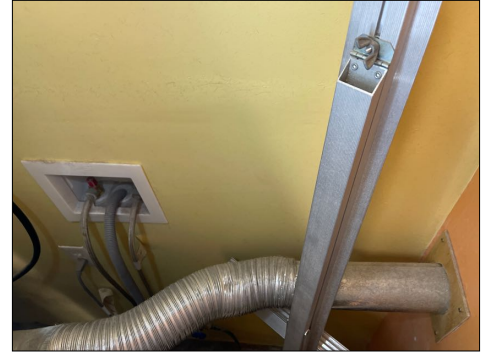
#### 2. Dryer Supply

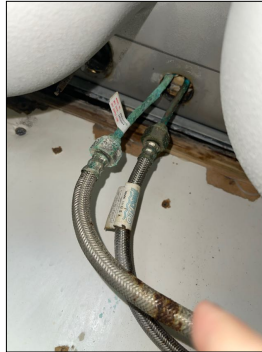
Evidence of sink fixture leaking down into the lower cabinet

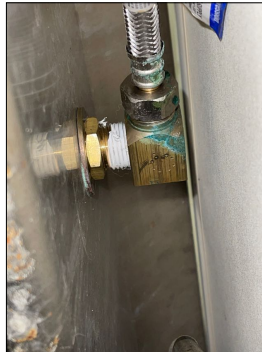
Evidence of a leak at the coke water connection

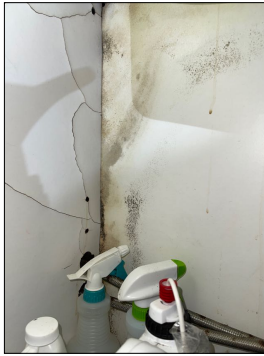
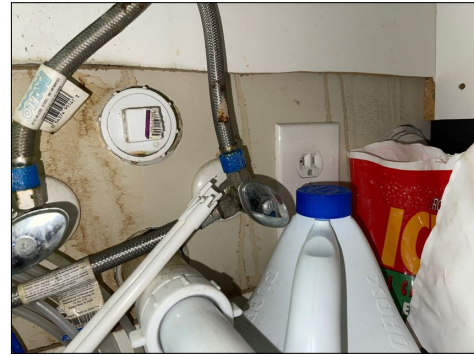
### 5. Registers/Vents

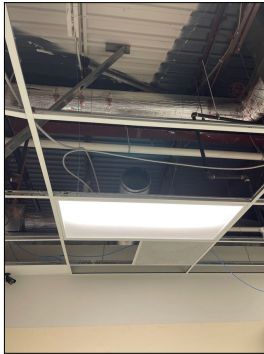
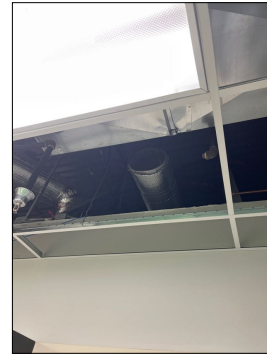
## NE Kitchenette/Office

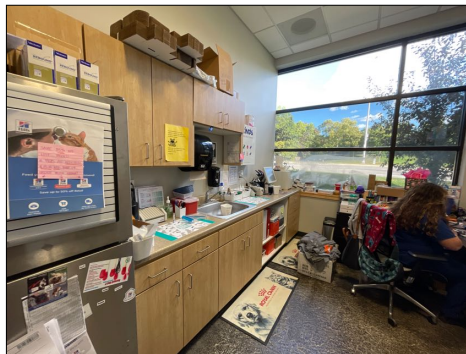
### 1. Kitchenette Picture

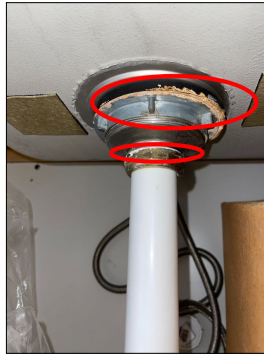
Evidence of a leak at the sink flange and the drain connection

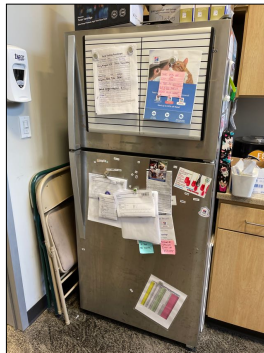
### 4. Window Condition

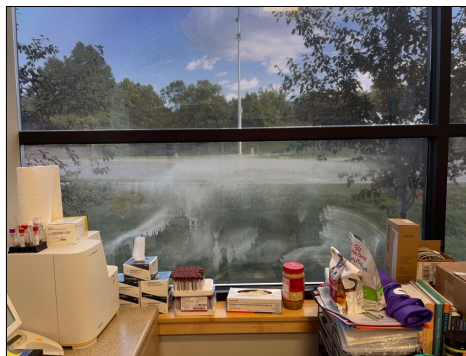
The Window Thermal Pane Integrity shows evidence of failure. The window panes have fogging and condensation between them. They can build enough condensation between the panes to rust through and cause water intrusion into the wall cavity. Recommend further evaluation for needed replacement.

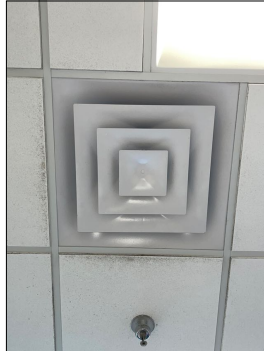
Evidence of Mold-Like substance and further evaluation is recommended.

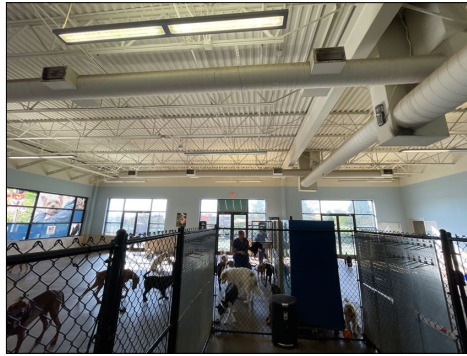
The south interior dog room has two S. side exterior doors without why did exit signs.

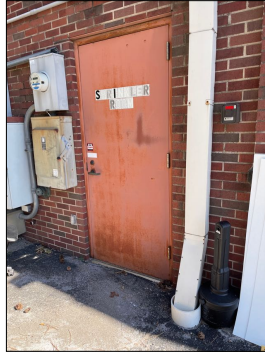
# FIRE SPRINKLER SYSTEM (continued)
