RC Certified Inspections

Comprehensive Structural & Mechanical Property Inspections

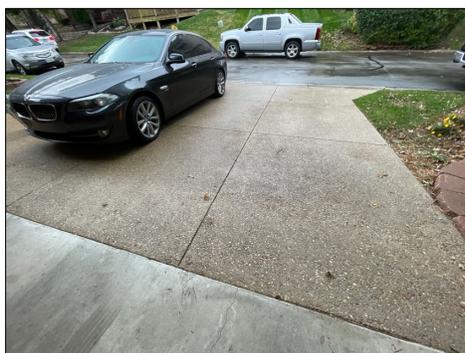
2. Porch/Stoop-Front

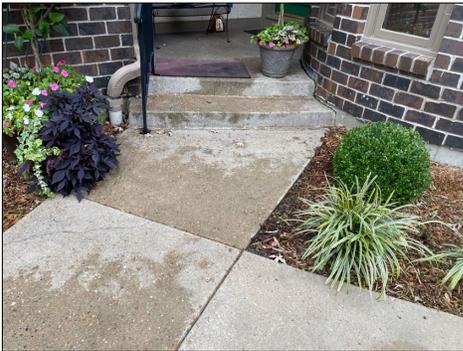
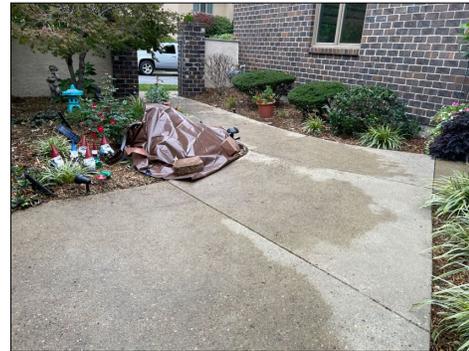
4. Soil Slope & Drainage

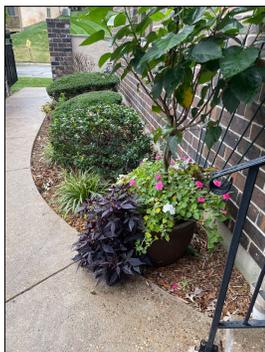
POOR DRAINAGE-CORRECT NOW

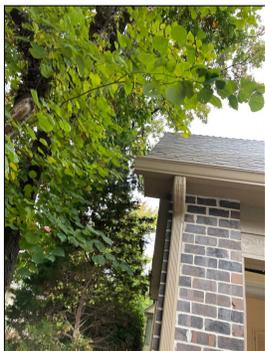
Tree limbs within 10 feet of roof should be trimmed away to provide air and sunlight to roof, while minimizing debris, damage & dampness to the roof surface. Referral: Bill Edington, D&B Tree Service at (913) 206-1533.

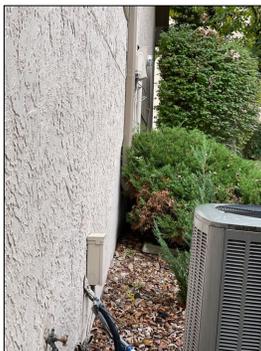
Prune or remove any plants that are in contact or within 12" of home to eliminate water damage to the siding surfaces or pathways for wood destroying insects.

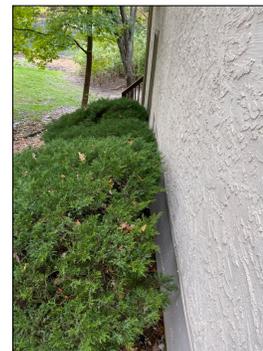
Prune or remove any plants that are in contact or within 12" of home to eliminate water damage to the siding surfaces or pathways for wood destroying insects.

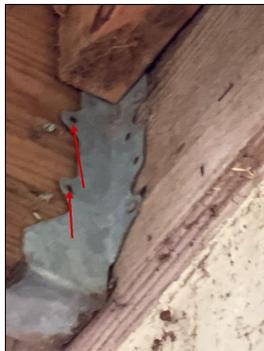
Joist hangers are missing fasteners were they attached to the sides of the floor Joists. JoistHangers must be installed using either Joist Hanger Nails or #8 or #10 Framing nails. Must have 8 fasteners per hanger.

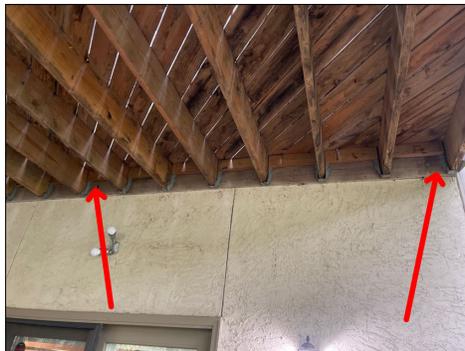
There are a few lag screws installed in the ledger board but there's not even close to being enough that is required.

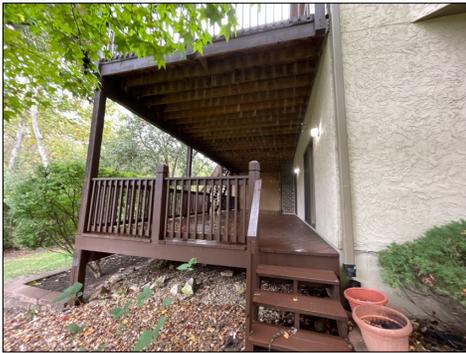
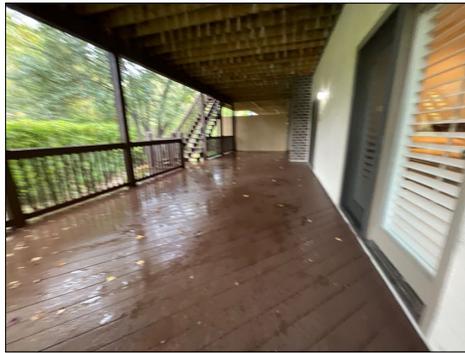
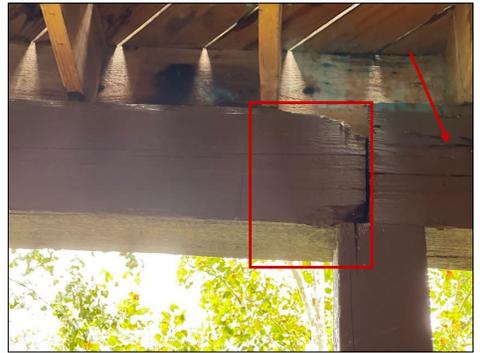
The upper deck west side Girder/Support Beam has water damage and also evidence of carpenter bees. Due to the height and size of the structure I am recommending further evaluation and possible replacement.

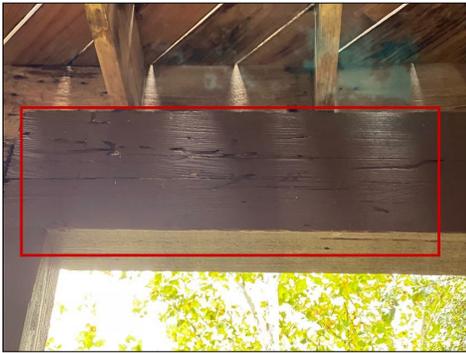
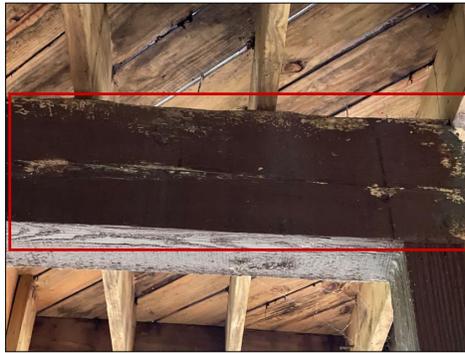
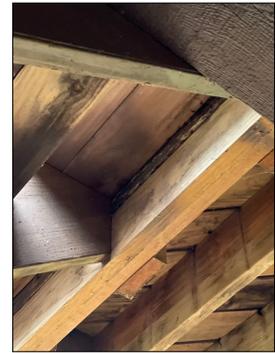
The upper deck west side Girder/Support Beam has water damage and also evidence of carpenter bees. Due to the height and size of the structure I am recommending further evaluation and possible replacement.

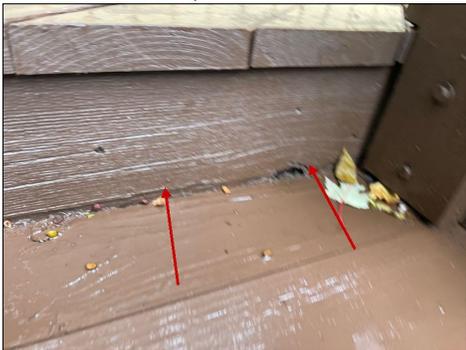
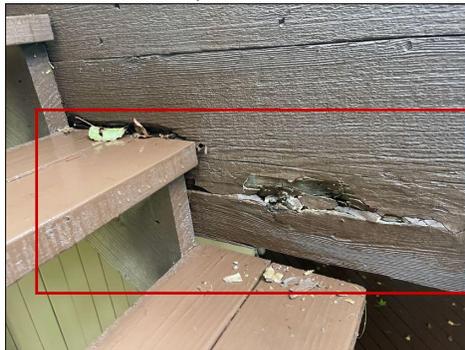
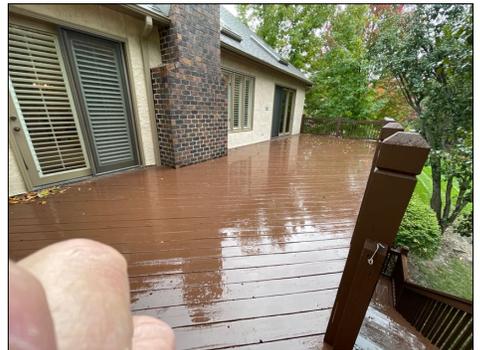
At the top of the stairs at the riser between the top step in the floorboards has water damage

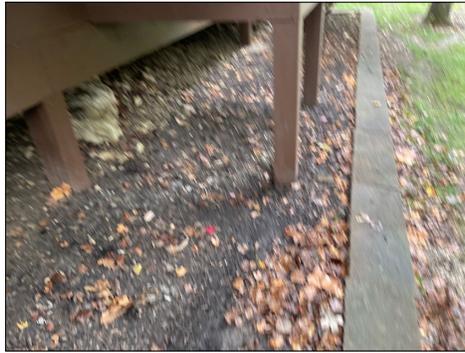
There are deck support posts there are in contact with the soil and needs to be continuously monitored.

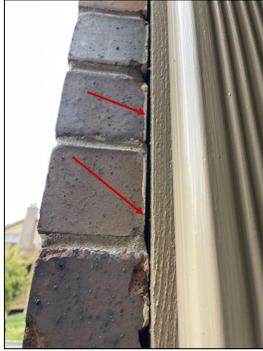
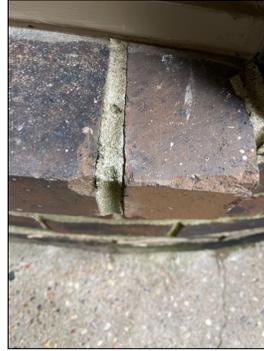
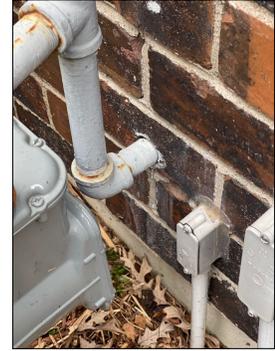
A brick on the north side of the garage at the front porch has a large gap between the brick and the corner trim. This needs to be properly filled in and sealed up. It appears that there are several other areas at the break edges and also needs to be sealed. Need to monitor the brick ledge mortar joints at the windows. They are just starting to open up and will need to be sealed in tuck pointed soon.

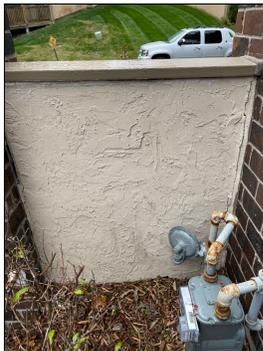
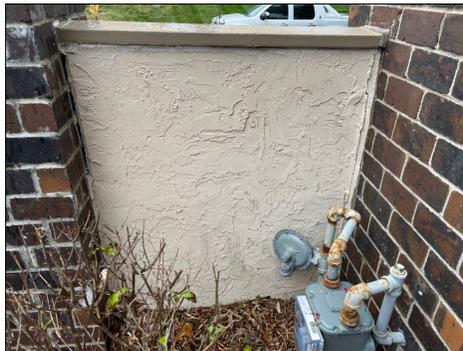
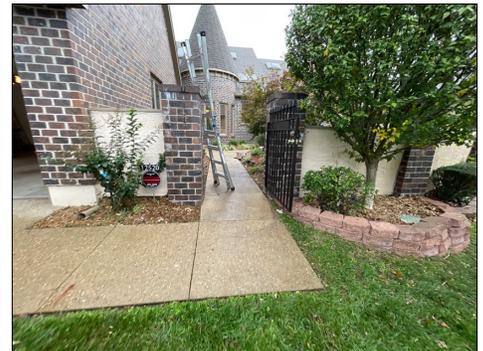
Both sides of the front entry stucco surfaces are loose. They are cracked and opening up at the edges and is in contact with the soil and ground covering. Both sides of the front entry stucco surfaces are loose. They are cracked and opening up at the edges and is in contact with the soil and ground covering.

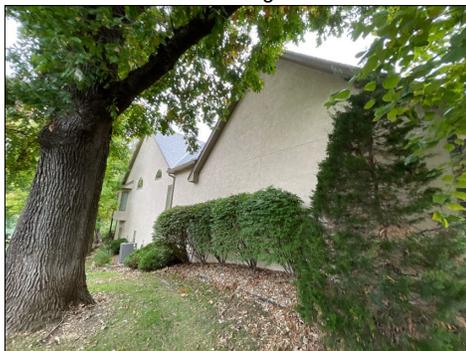
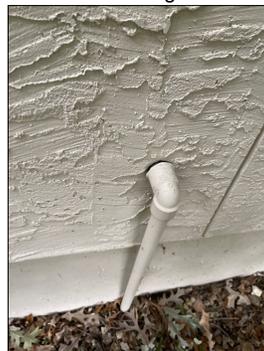
Need to seal up around the exterior sprinkler system electrical conduit on the south side of the garage.

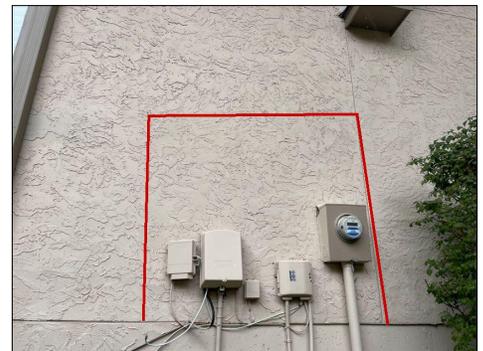
Water is getting in behind the main electric meter at the stucco surfaces causing water damage behind the stucco surfaces at the electric meter and the cable boxes. This area will need to be cut out and repaired.

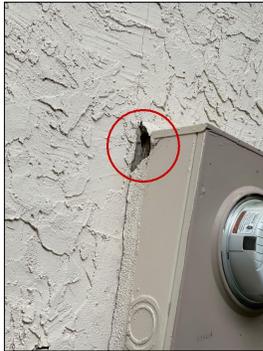
Water is getting in behind the main electric meter at the stucco surfaces causing water damage behind the stucco surfaces at the electric meter and the cable boxes. This area will need to be cut out and repaired.

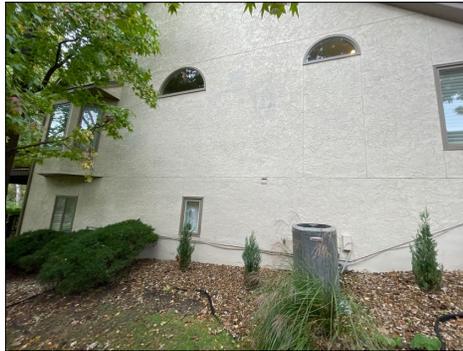
The south side of the Home Stucco surfaces has quite a few vertical cracks but also has a larger horizontal crack at the lower level west of the air conditioning condenser at a window. The smaller cracks can be skim coated Betty horizontal crack appears to have loose material and may need to be removed and replaced.

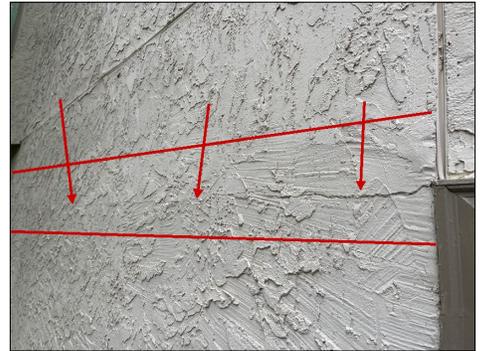
The south side of the Home Stucco surfaces has quite a few vertical cracks but also has a larger horizontal crack at the lower level west of the air conditioning condenser at a window. The smaller cracks can be skim coated but the horizontal crack appears to have loose material and may need to be removed and replaced.

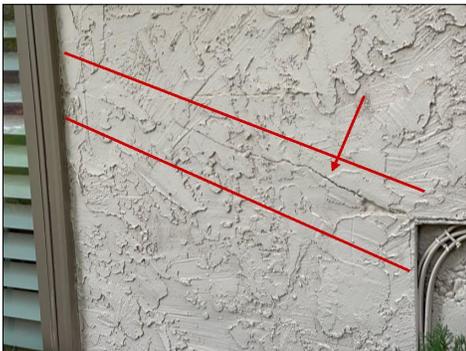
The south side of the Home Stucco surfaces has quite a few vertical cracks but also has a larger horizontal crack at the lower level west of the air conditioning condenser at a window. The smaller cracks can be skim coated Betty horizontal crack appears to have loose material and may need to be removed and replaced.

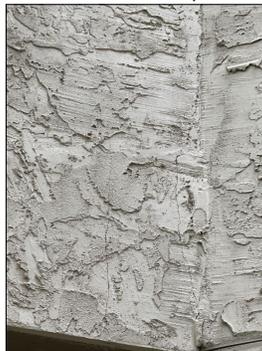
The south side of the Home Stucco surfaces has quite a few vertical cracks but also has a larger horizontal crack at the lower level west of the air conditioning condenser at a window. The smaller cracks can be skim coated Betty horizontal crack appears to have loose material and may need to be removed and replaced. ** Picture at MBR Bay Window

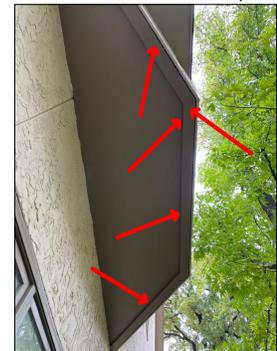
Need to seal up the edges of the master bedroom bay window on the south side of the home at the soffit area.

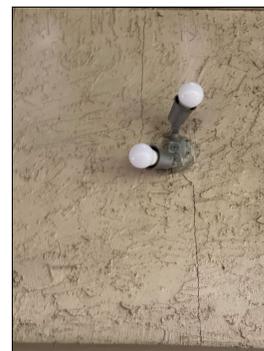
Vertical cracks on the west side above the south basement door running from the deck ledger board down to the door casement.

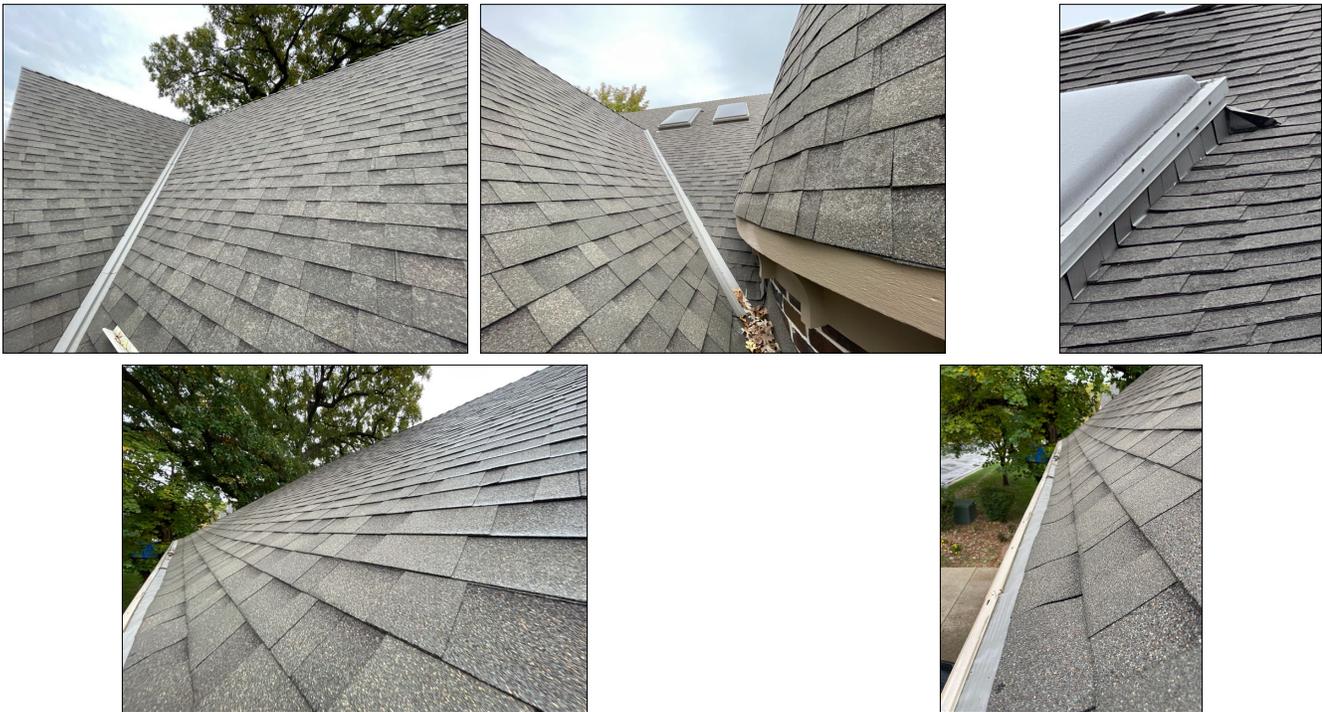
2. ROOF Material/Age

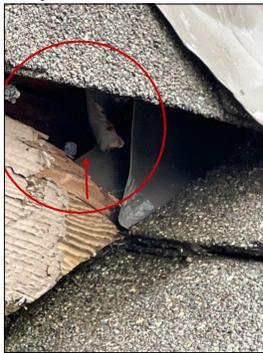
The kitchen round brick structure northside at the bottom of the valley there are openings above the flashing and also some wood damage that doesn't help. This needs to be properly flashed now.

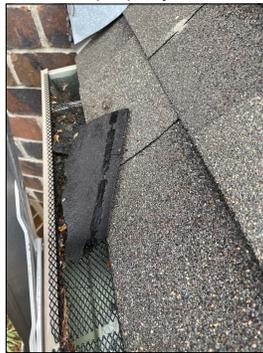
There is a shingle tab lying in the gutter above the kitchen roof area. It appears to have broken loose below the gutter area where there's flashing located.

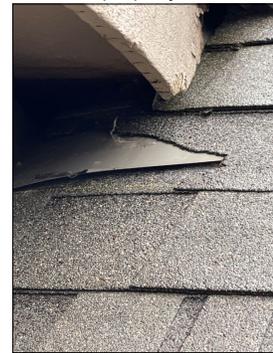
There is a shingle tab lying in the gutter above the kitchen roof area. It appears to have broken loose below the gutter area where there's flashing located.

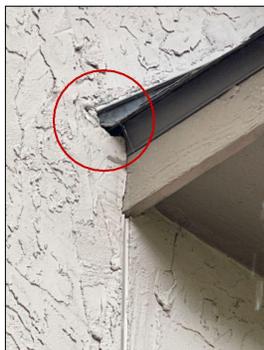
Missing Kick Out Flashing's need to be installed at: On the south side of the garage above the electric meter area.

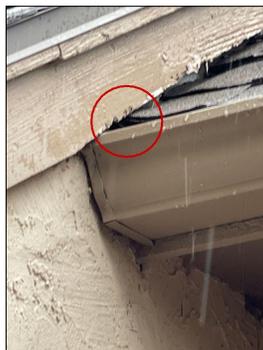
Missing roof kick out flashing on the west side at the north end of the gutter north of the chimney area.

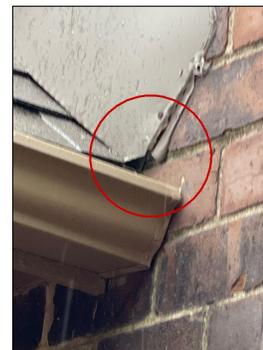
Missing roof kick out flashing on both sides of the chimney.

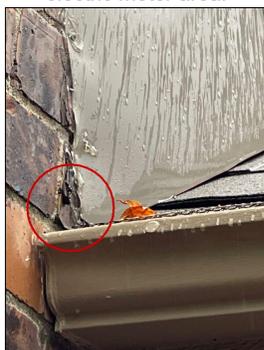
Missing roof kick out flashing on both sides of the chimney.

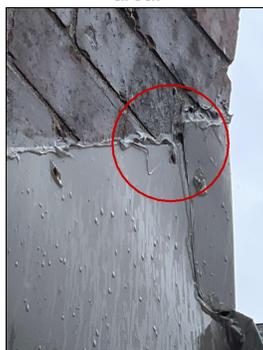
The metal roof flashing of course is attached to the surface of the chimney brick and the sealant along the top of the counter flashing will need to be checked every three years. ** There are areas now that need to be sealed **

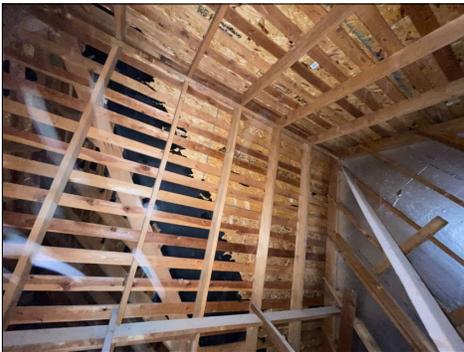
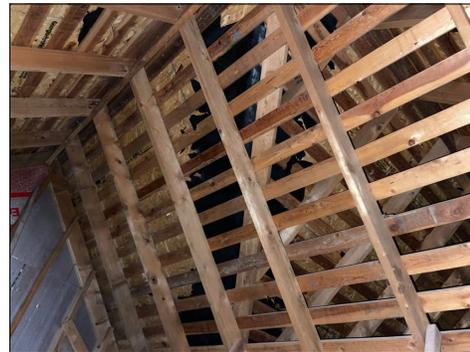
There aren't any roof vents installed. There should be 1-Sq. Ft. (1-Vent) per every 150 Sq. Ft. of Attic Flooring (Ceiling surface under attic space). Recommend further evaluation and correction. ** Garage**

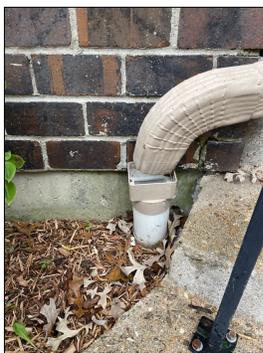
The downspout at the front porch is supposed to be emptying into an underground drain and it needs a reducer installed on the downspout so it goes down inside the underground pipe.

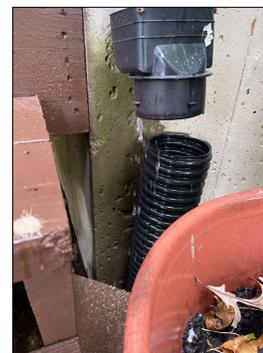
The far south west corner downspout has become disconnected from the underground drain pipe and is dumping water against the foundation. There should be a reducer that extends down into the underground pipe at least 8 inches to prevent this. The downspout should never be securely attached to the underground pipe.

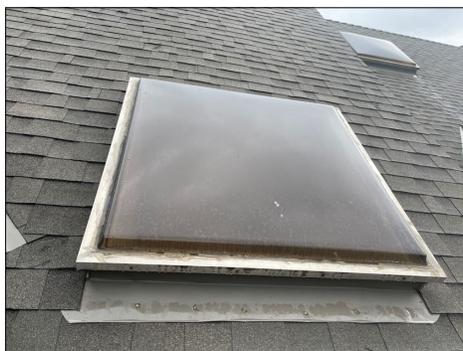
The Skylight(s) appear to beyond their life expectancy. Recommend replacement. MONITOR

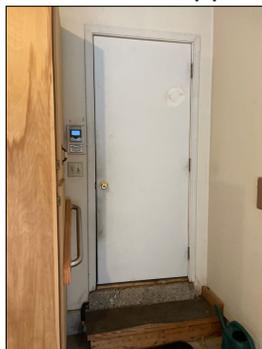
5.1. Need to install new door casement weatherstrips due to damage and/or current ones don't seat at the threshold and/or not properly fitted at the upper corners.

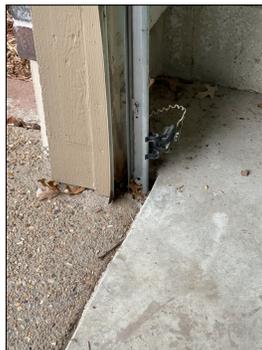
8.1. Safety reverse sensors are working as intended and are installed between 3" to 6 inches (6" Maximum) above the floor surface as intended.

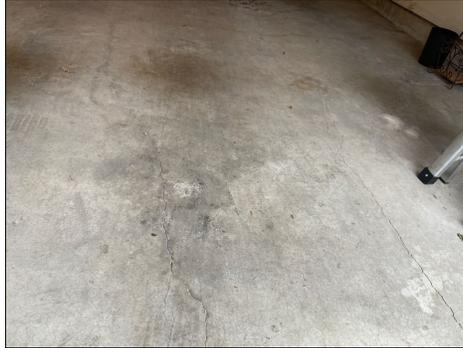
10. Window Condition

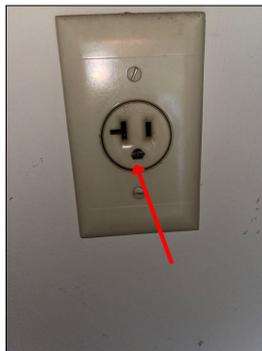
The garage West receptacle for an appliance has a broken ground plug in the socket.

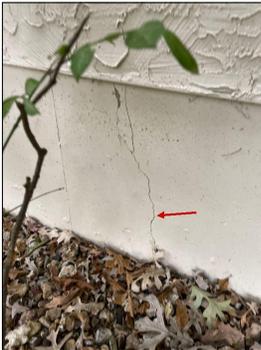
The southside foundation at the garage area has a couple of cracks which appear to be having some movement. The drainage is extremely bad along the side which causes issues with the foundation.

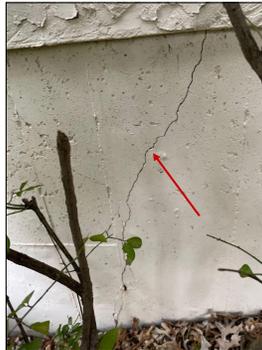
The southside foundation at the garage area has a couple of cracks which appear to be having some movement. The drainage is extremely bad along the side which causes issues with the foundation.

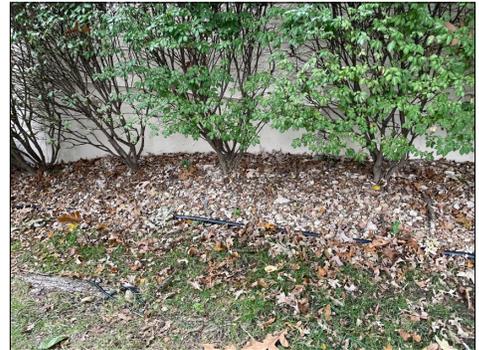
The southside foundation at the garage area has a couple of cracks which appear to be having some movement. The drainage is extremely bad along the side which causes issues with the foundation.

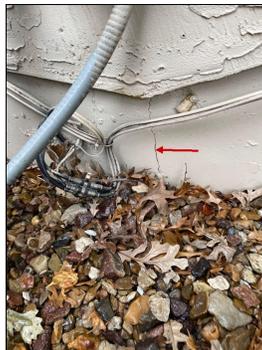
Foundation crack noted behind the air conditioning condenser.

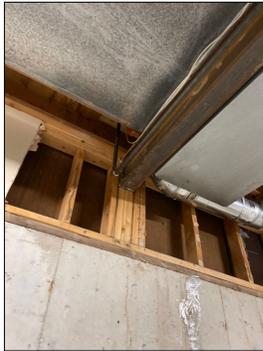
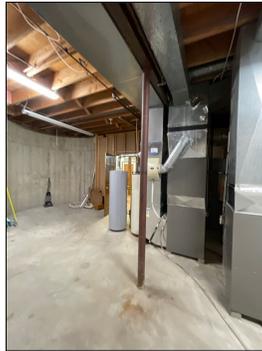
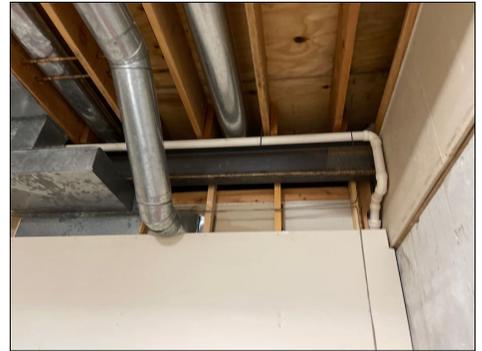
2.3. Steel I-Beam Girders and steel support post/columns present.

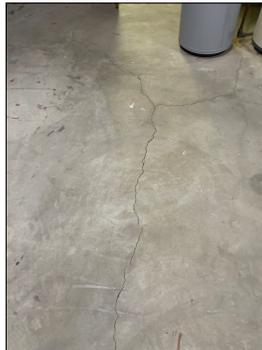
Typical slab cracking.

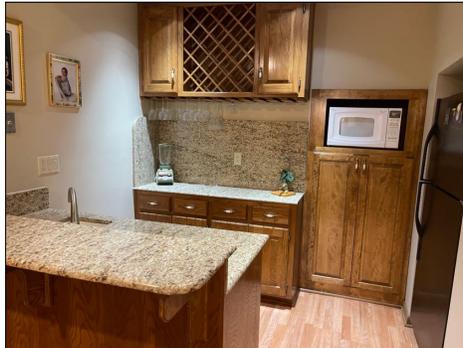
8.1. Garbage disposal is not operating

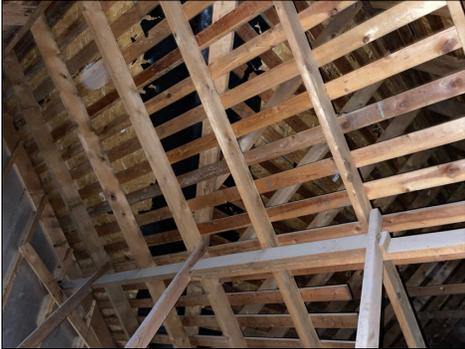
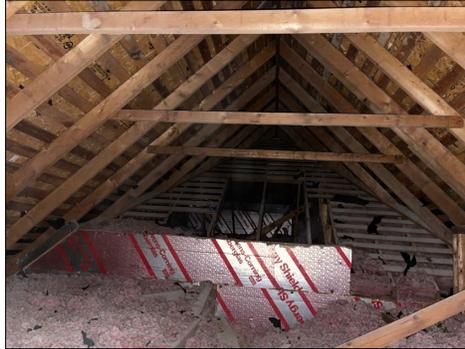
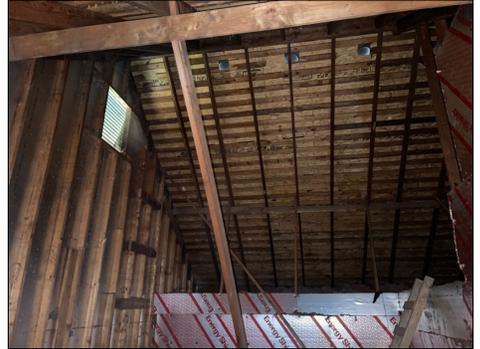
3. Rafter Purlins Bracing

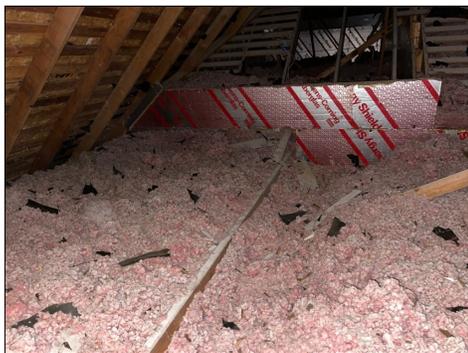
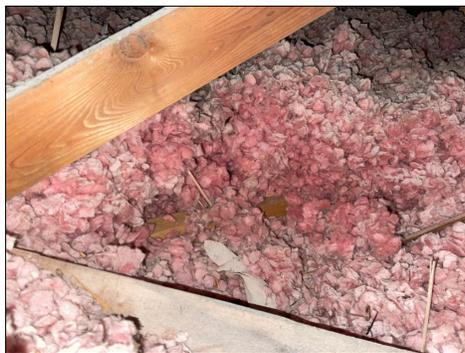
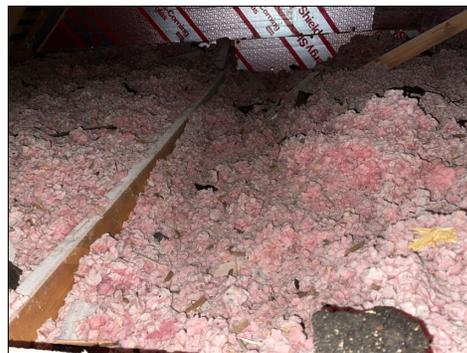
Exposed Ceiling Joists noted in several areas or throughout. This can cause Thermal Bridging which is when heat escapes into the cold attic space causing condensation issues. Recommend additional insulation to correct this. There needs to be insulation added now!

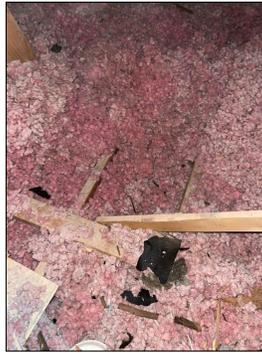
Exposed Ceiling Joists noted in several areas or throughout. This can cause Thermal Bridging which is when heat escapes into the cold attic space causing condensation issues. Recommend additional insulation to correct this. There needs to be insulation added now!

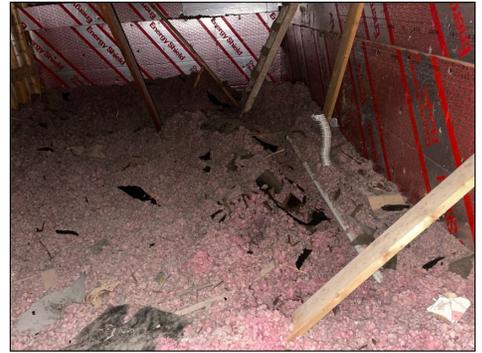
There has been foot traffic in areas in the attic which has lowered the height of the insulation that should be corrected.

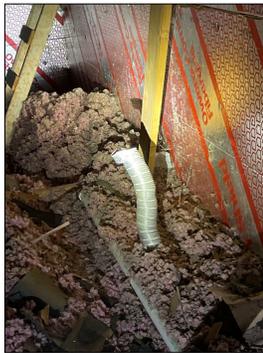
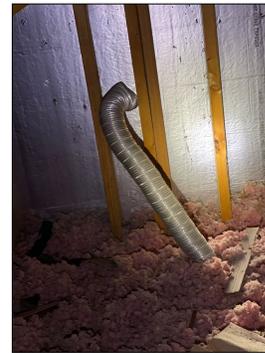
On the far south wall there is an exhaust hose that's pushed up against the exterior surfaces and needs to be redirected.

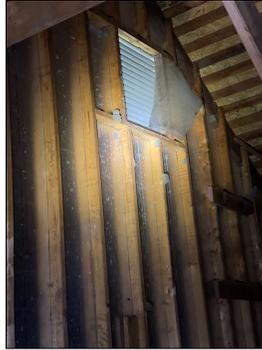
Vent screens are damaged or missing, suggest repairing or replacing screens as necessary. Birds and Vermin can enter the attic.

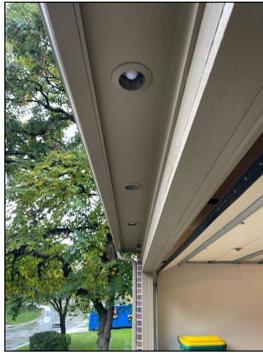
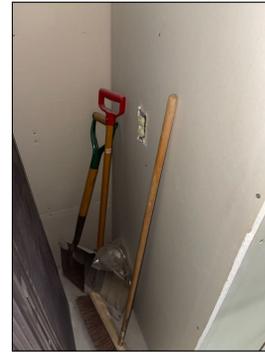
Missing or Damaged Receptacle Covers at: furnace room sw corner at the wet bar bump out

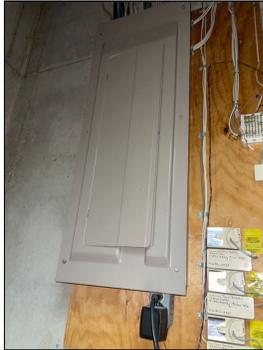
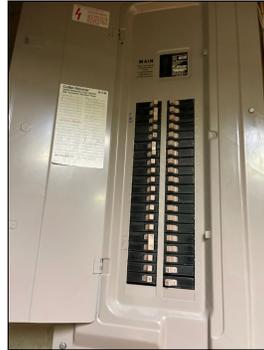
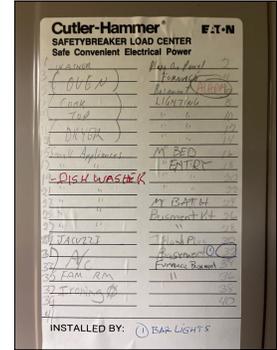
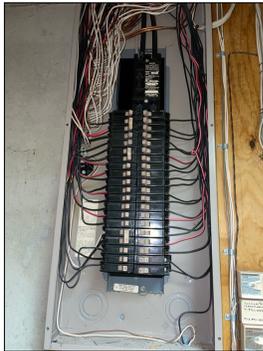
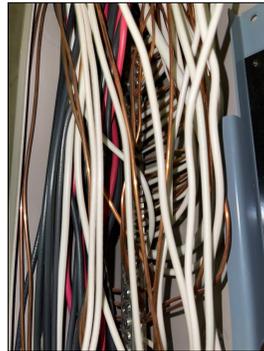
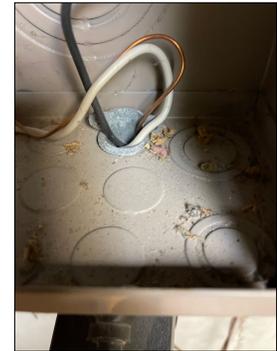
There are White Neutral Wires on the neutral bars that are tapped together with other neutral and or ground wires. All Neutral wires must be on their own terminal and can not be tapped together with other neutral or ground wires per National Electric Codes 408.21 or 408.41 and also refer to 110.3(B). You are allowed to twist 3 ground wires together and put them on one terminal to make room if needed.

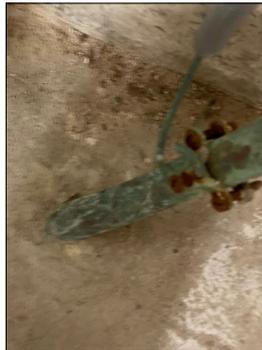
5. Ground Rod-Underground

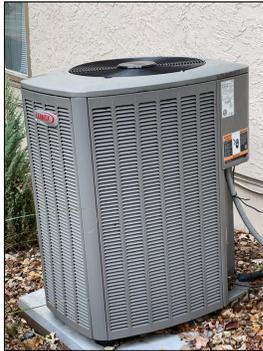
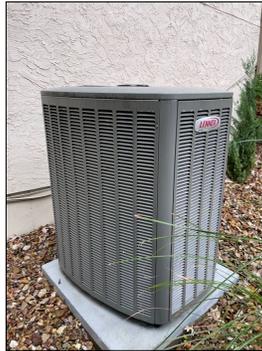
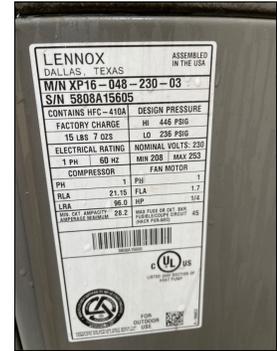
2. Air Conditioning System

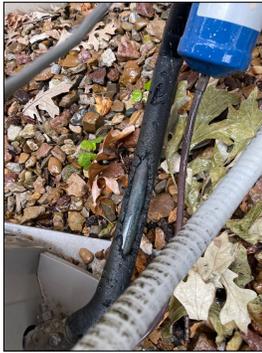
Exterior air conditioning refrigerant lines needs new insulation installed.

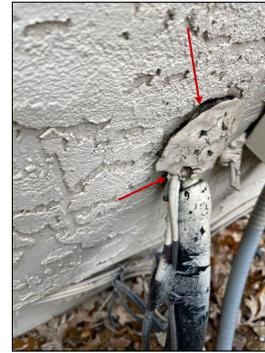
Need to seal up around the exterior air-conditioning refrigerant lines were enters the siding with Thumb Gum Sealant.

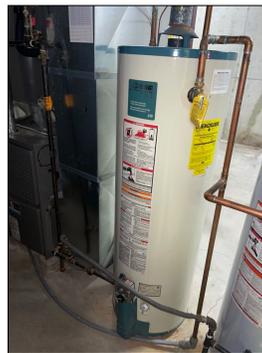
IPR Valve is upside down.

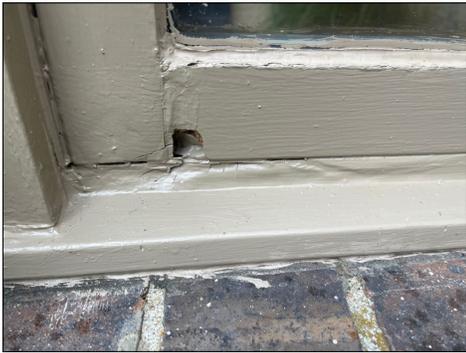
The kitchen breakfast nook bay window, north window bottom frame and window glass rails and sash are rotted out.

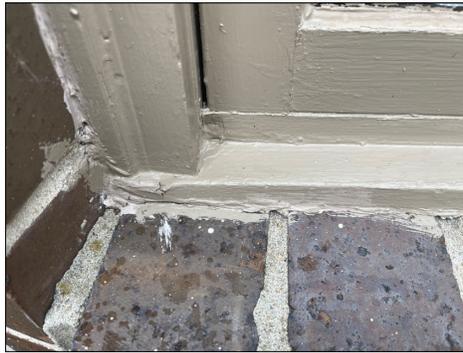
Kitchen breakfast nook bay window second window from the north side has water damage to the bottom of window casement and the window sill.

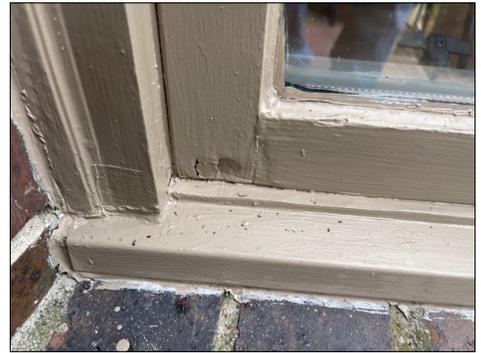
The kitchen breakfast nook bay windows, both of the south windows have rotted window glass rails and sash and bottom window casement.

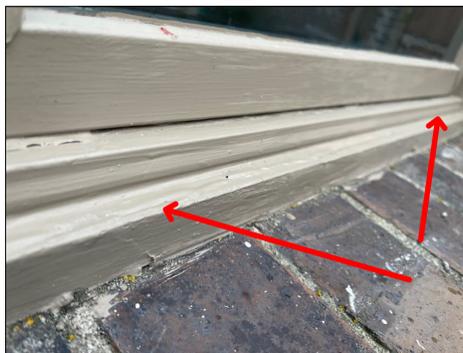
Garage north side windows has water damage to the bottom casement sill area at the brick.

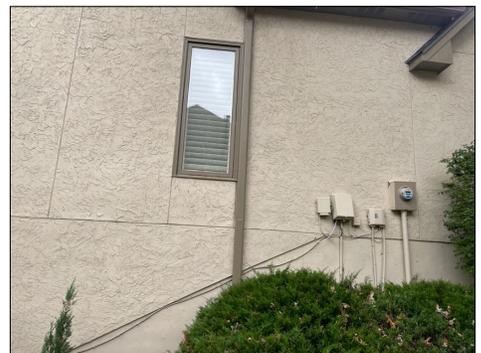
The casement window on the southside between the electric meter and the air conditioning condenser has water damage to the window glass extrusions in the bottom casement and sill area.

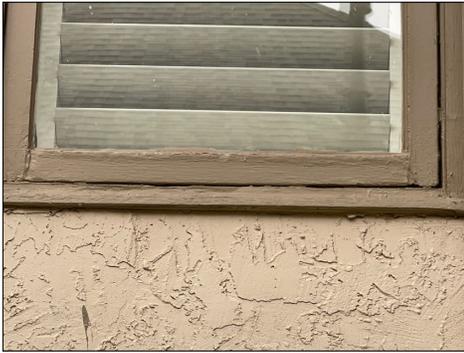
The casement window on the southside between the electric meter and the air conditioning condenser has water damage to the window glass extrusions in the bottom casement and sill area.

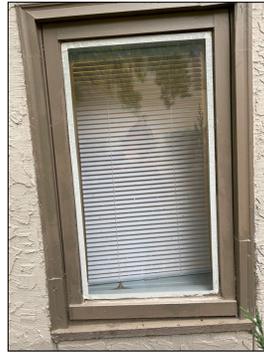
Southside lower window west of the air conditioning condenser is in very poor condition. Brick molding has been patched in with sections, the window sags and there is a gap at the bottom.

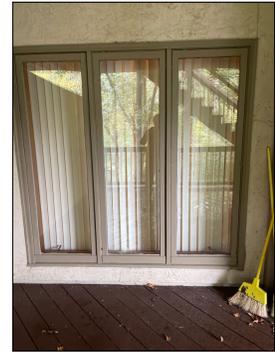
The triple casement windows on the lower deck north side of the brick chimney are in poor condition and has had woods/trim attached to the bottom of the windows.

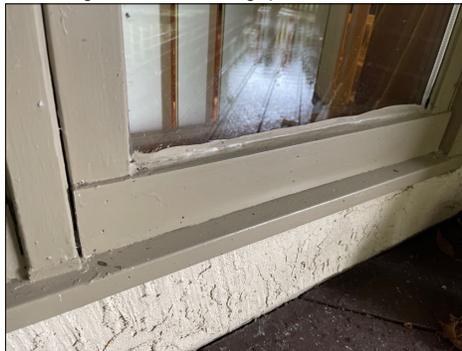
The triple casement windows on the lower deck north side of the brick chimney are in poor condition and has had woods/trim attached to the bottom of the windows.

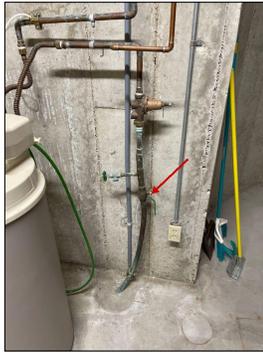
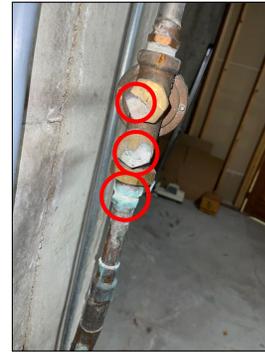
Evidence of corrosion at the pressure regulator and the pressure regulator connection

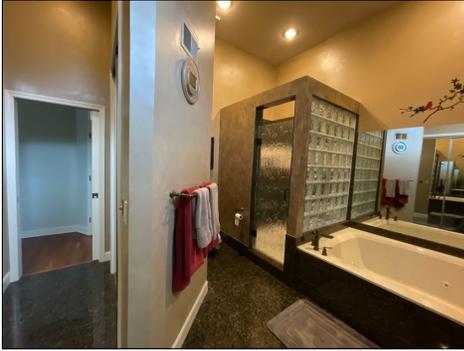
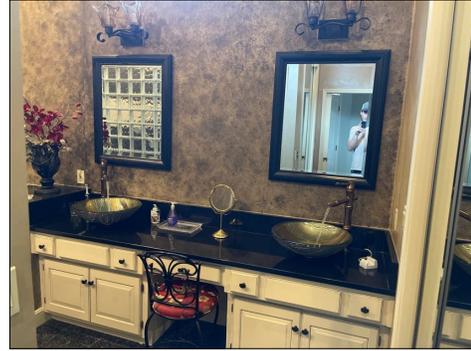
1. Location Basement Bathroom

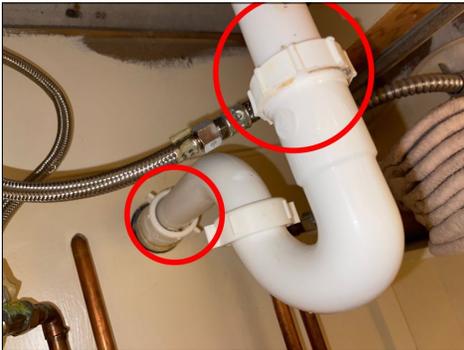
Evidence of a leak at the east sink drain line trap connection and wall drain connection

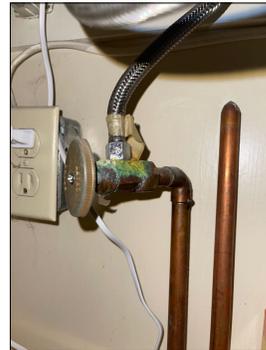
Evidence of a leak at the hot water shut off valve

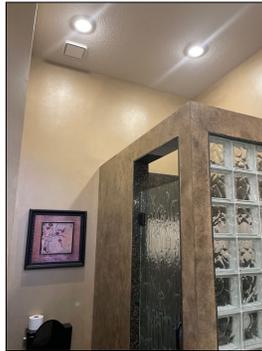
- 9.1. The bath fan was operated and no issues were found at the time of the inspection.
- 9.2. Exhaust fan needs to be vacuumed out and cleaned.

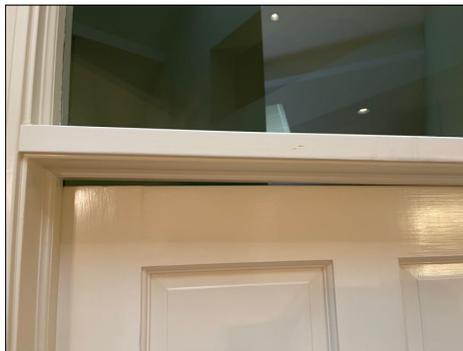
Recommend adjusting the doors hinges so it creates a seal around the casement instead of having a gap along the top

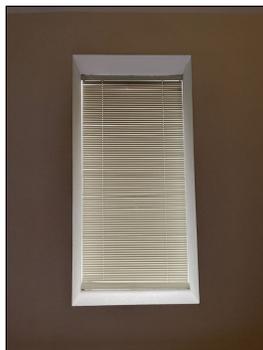
The skylight is covered with blinds and could not be inspected

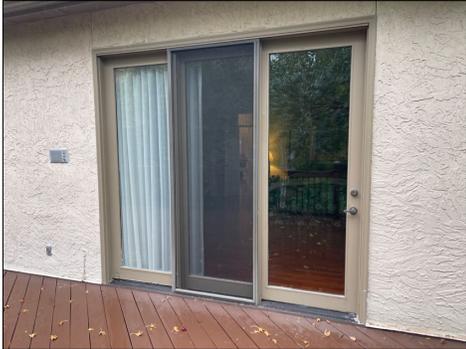
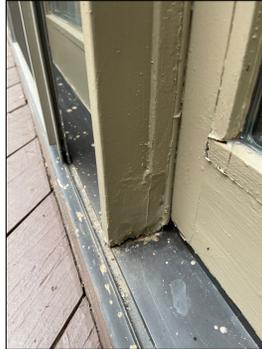
Water damage to the exterior vertical wood section between the opening door in the center stationary section.

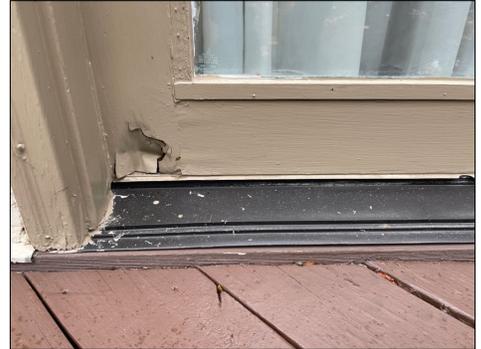
The north stationary section has wood damage. When I push on the surface it collapsed.

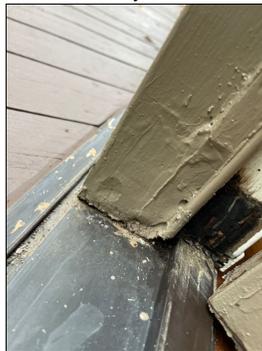
There is Water Damage at the Door Casement south side. The north side has been replaced

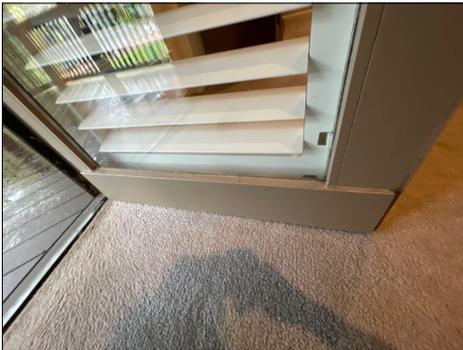
Seems as though a piece of wood trim was placed along the bottom of the exterior of the side. This could be evidence of previous wood damage on the door

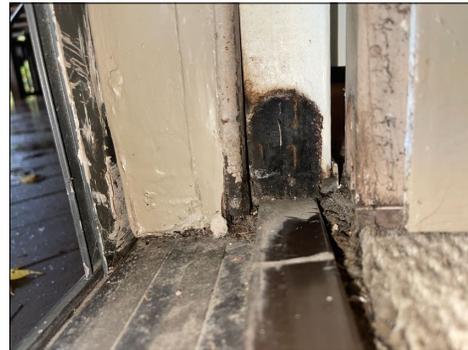
Recommend caulking the corners of the casement behind the weatherstrips at the threshold. There's gaps can allow bugs and possibly water into the home.

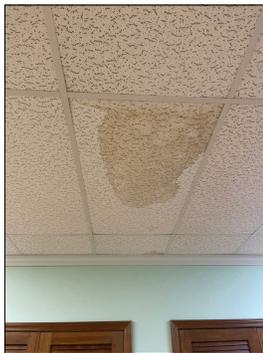
Evidence of Water Stains noted at: center of room

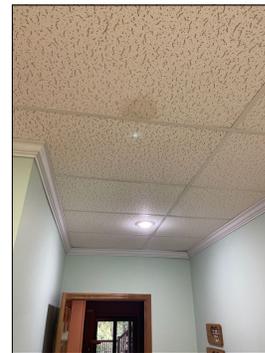
Evidence of Water Stains noted at: 5 panels inside of room from door

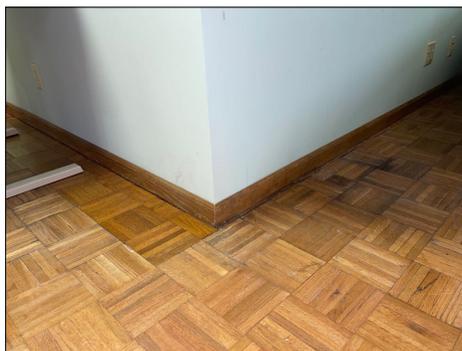
Evidence of water damage around the corner of the north wall and north end east wall

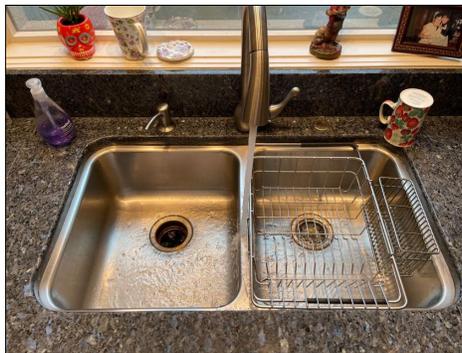
Materials: Double stainless steel sink • Mounted under the counter top. Need to often check for possible leaks where the sink mounts to the counter top. Typically, on double sinks, check at the divider at the front and back.

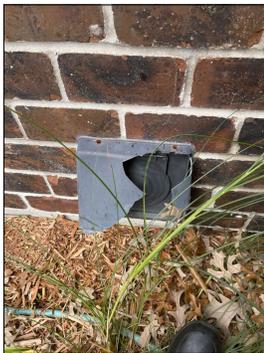
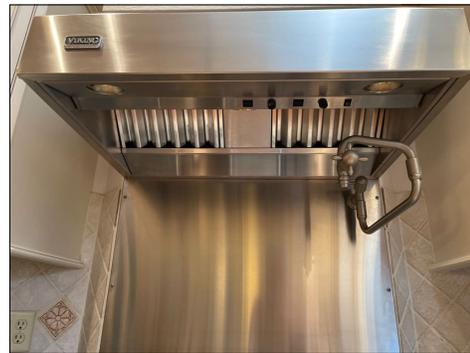
The exterior exhaust fan cover is damaged and needs to be replaced.

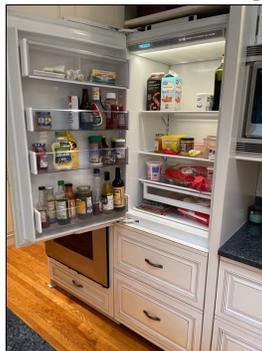
15.2. The upper freezer drawer rubs against the wood fridge door

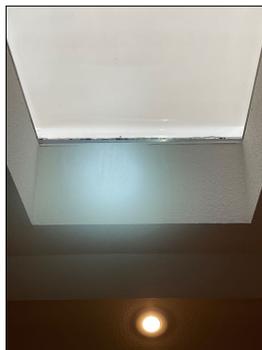
LIVING ROOM (continued)

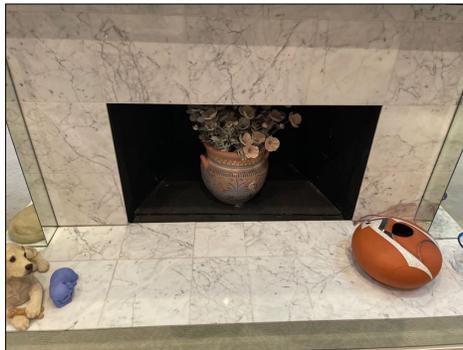
9. Doors-Exterior Rear

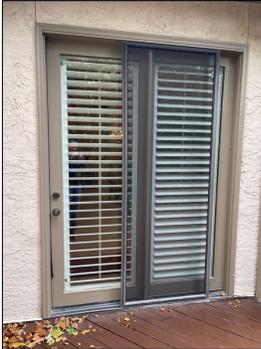
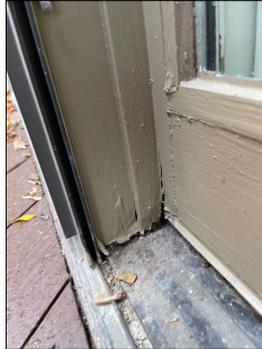
The exterior vertical divider between the main door in the station in the door has water damage.

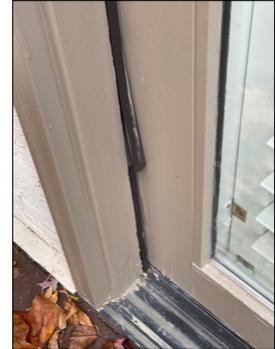
Damaged weatherstripping

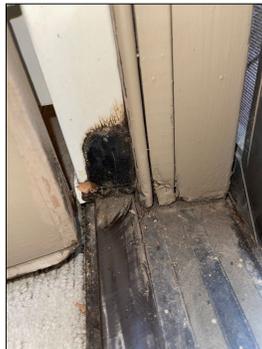
There is Water Damage at the Door Casement.

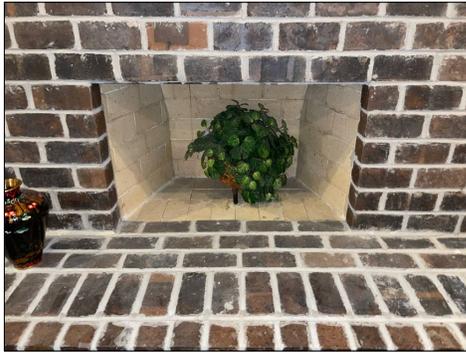
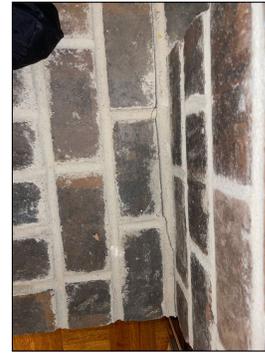
Hearth crack along the north end

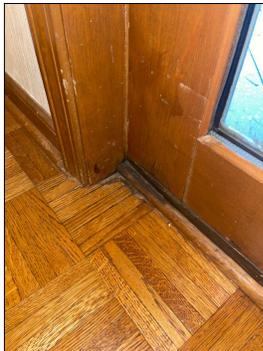
Water intrusion coming in at the south corner of the door where the casement has a gap at the weatherstrip that leads inside

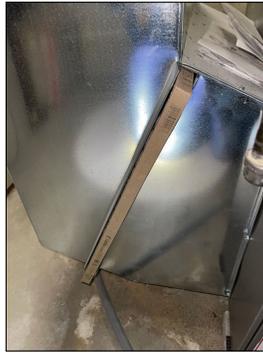
West Small Furnace (continued)

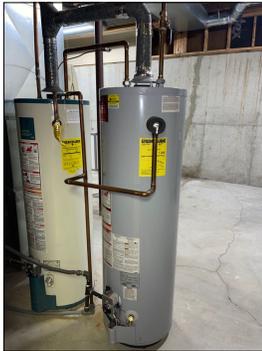
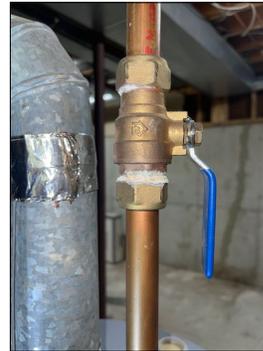
Evidence of a leak at the cold water shut off valve connection

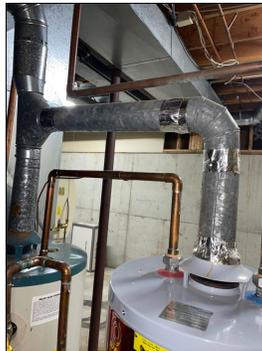
The flue from this unit to the connection above the west unit should have a slightly better slope for drafting. It was not showing any back drafting at this time. When the old water heater is replaced, it should be corrected at that time.
